Hymac 580BT Restored to 'As New'

Rare Hymac 580BT gets the full works by Julian Carder and what a stunner it is, says Jeremy Rowland

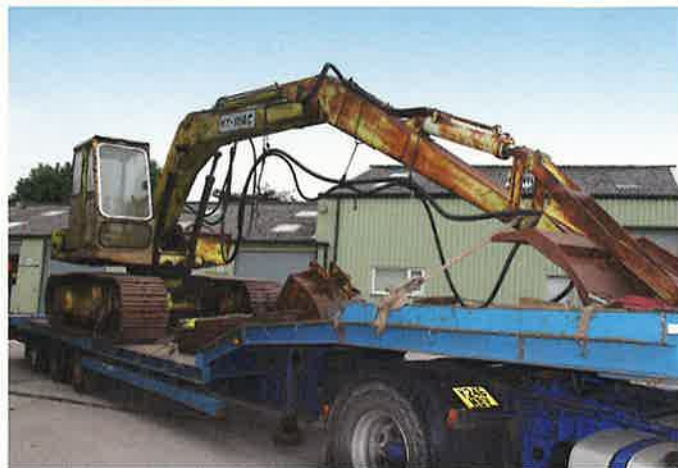
The Hymac 580BT as she arrived on the low-loader from South Wales - all there but she had suffered from the ravages of time stood in a barn

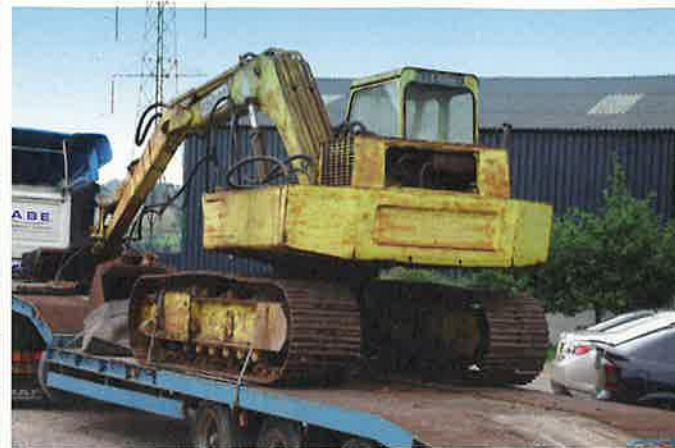
This rear shot of the excavator on the low-loader show the registration number that dates the machine as a very early example; the 580BT appeared in late 1967 with production lasting till 1970

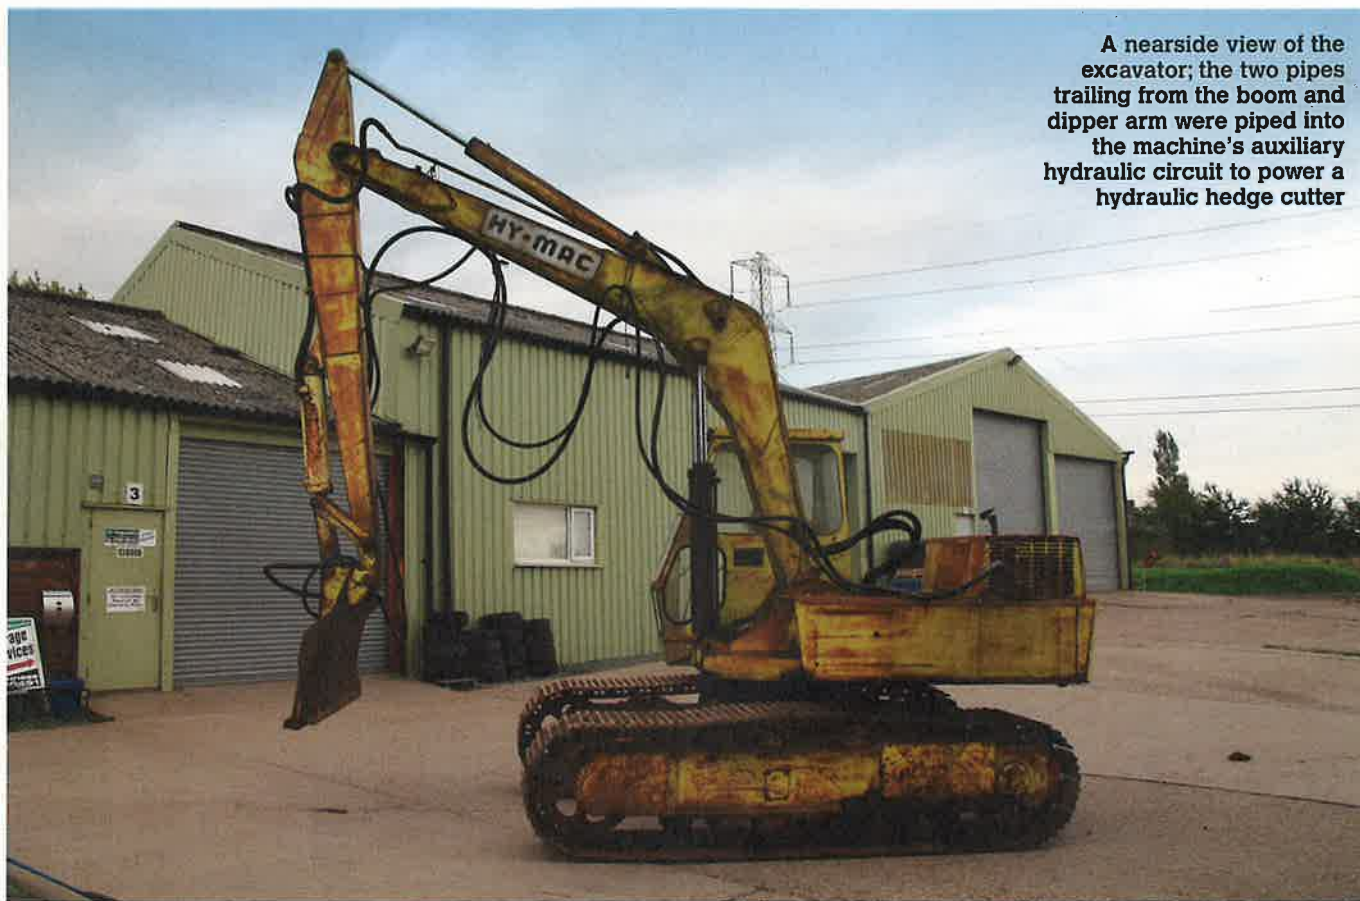
A nearside view of the excavator; the two pipes trailing from the boom and dipper arm were piped into the machine's auxiliary hydraulic circuit to power a hydraulic hedge cutter

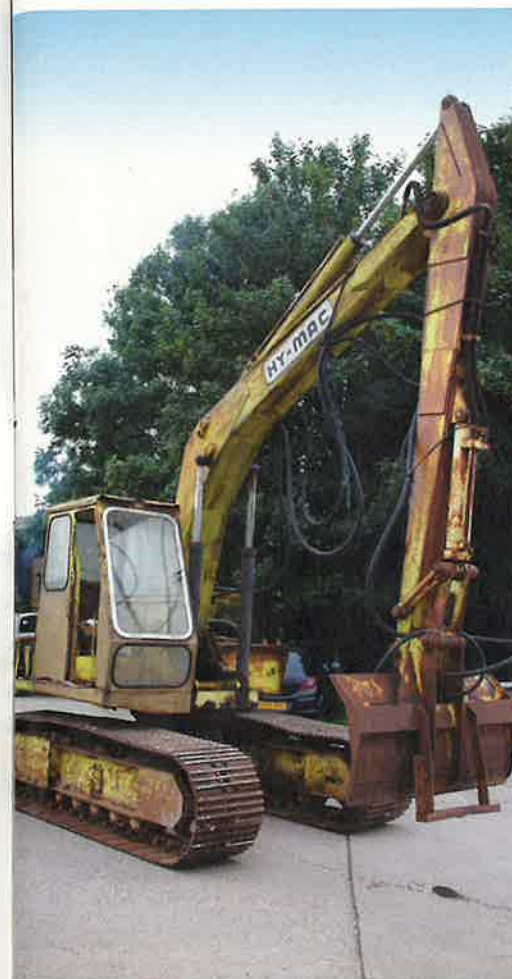
This offside view of the machine shows the rot along the bottom of the cab, quite normal for a machine that is now fifty years old

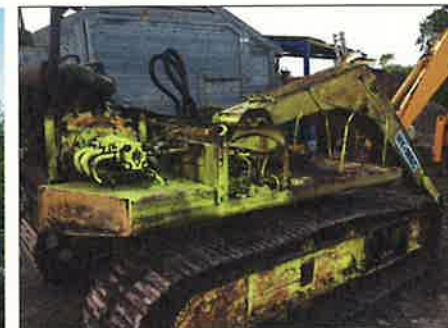
Left: Within a week of being unloaded the Hymac was already well stripped in this photo supplied by Julian Carder **Right:** A rear shot of the upper works with the rear counterweight removed; note the old dynamo fitted to this machine, no alternator here (Photo courtesy Julian Carder)

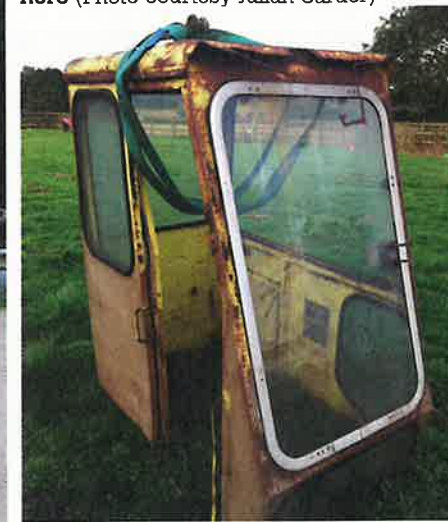
Left: The original cab from the Hymac - although this was replaced it is interesting to note that it still retains all of its glass as many older excavators tend to get their cab glass broken and not replaced **Right:** With the brake cylinder refitted only the brake adjustment and refitting the cover plate are left to be done. (Photos courtesy Julian Carder)

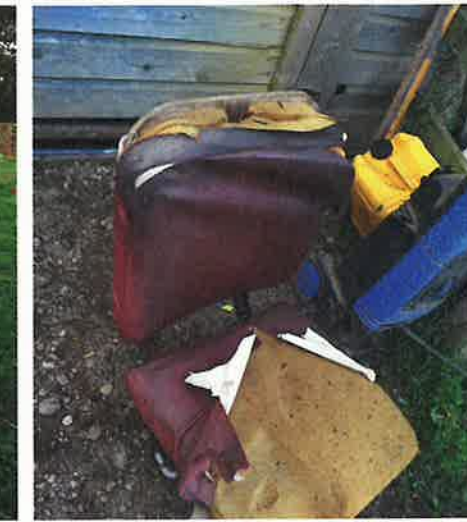
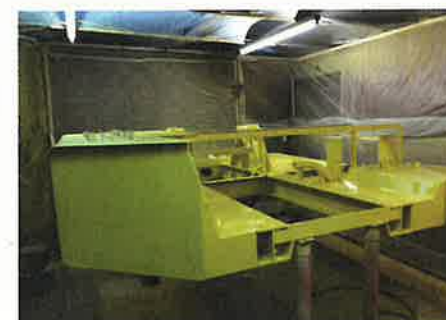
Left: A rear photo of the upper platform painted and ready for fitting back on the excavator (Photo courtesy Julian Carder)

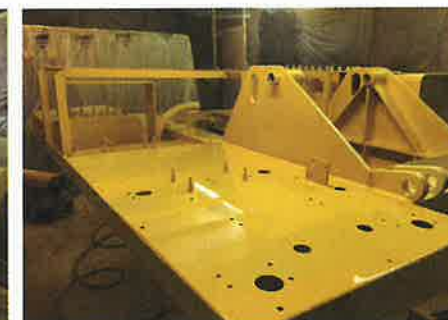
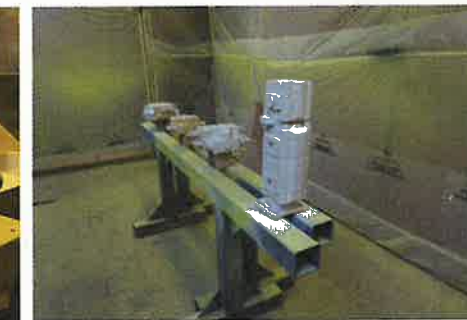
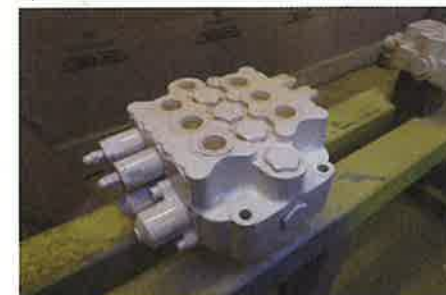
Middle: A front view of the platform showing the new cab floor (always a favourite to rot through) and the repaired boom mounting 'A' frame (Photo courtesy Julian Carder) **Right:** The reconditioned Commercial hydraulic triple in-line gear pump stands on end next to the three spool valves that were all reconditioned and tested by Tony Flint, the items are primed ready for undercoat to be applied

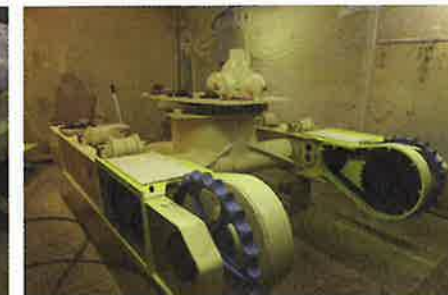
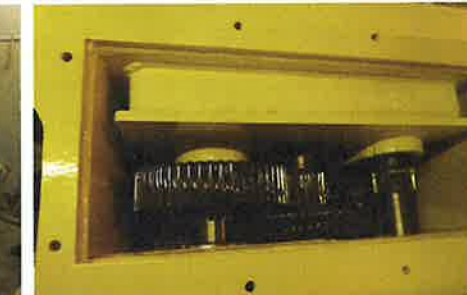
Left: A close up of one of the three spool valves fitted to all of Hymac's 580 machines, these are connected by control rods to the operator's control levers in the cab **Middle:** The undercarriage in the paint booth with the undercoat applied; the Staffa motor and slew ring have also been fitted, the motor rotates the machine's upper works when the slew function is operated **Right:** Peering inside one of the two track drive gearboxes after refurbishment, on occasion these gears have been known to fail on older machines

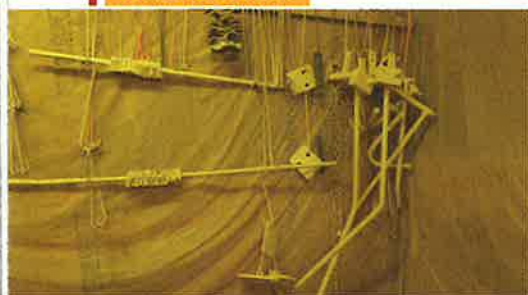
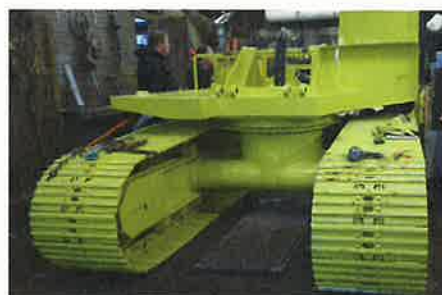
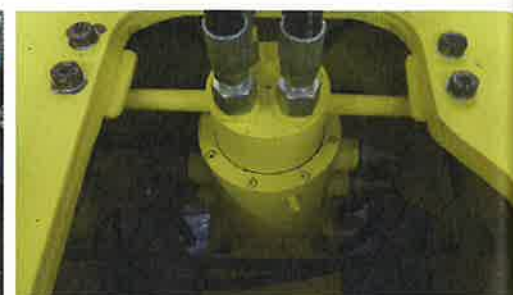
Left: Painted parts drying in the paint booth including the control operating levers and foot pedals; painting parts off the machine can enable a better finish as no area gets missed **Middle:** With the tracks fitted back on the machine and the upper platform refitted the 580BT slowly starts to take shape **Right:** The centrally-mounted rotary distributor fitted back into place; this was a good second hand unit which only required resealing

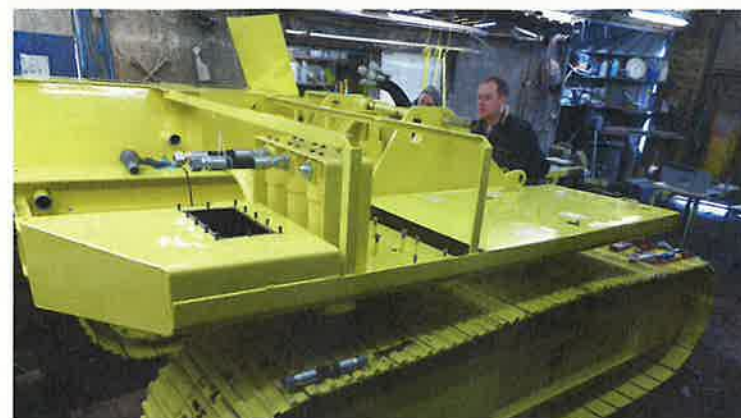
Julian inspecting the work recently carried out on the excavator; two of the three hydraulic pump to the hydraulic filter pipes have been fitted and the pick-up tank lies beneath them

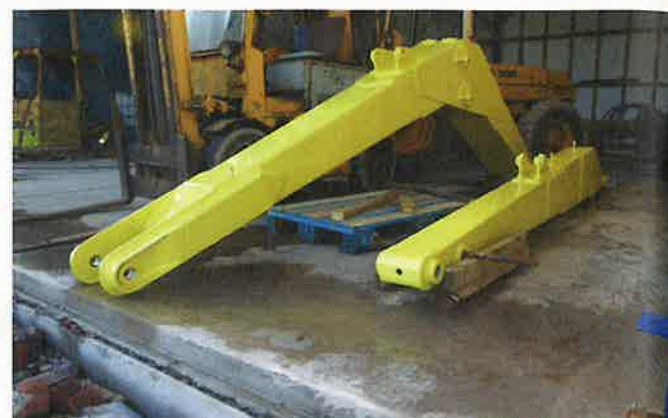
The restored boom and dipper arm ready to be fitted back onto the Hymac. You can see the old cab in the background

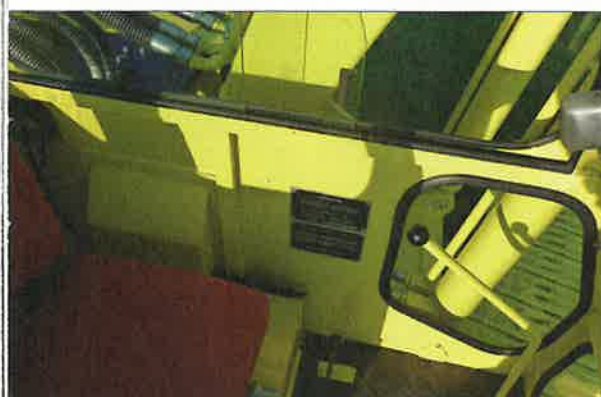
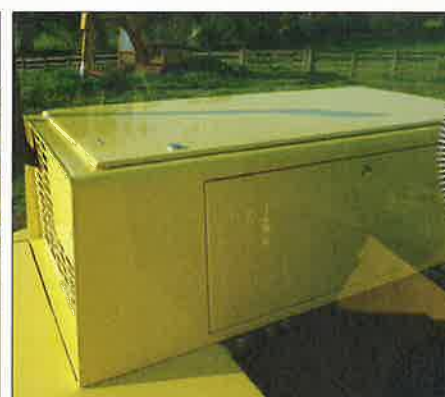
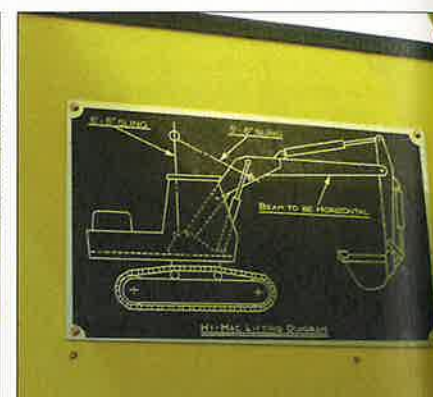
Left: From the newly cushioned seat to the internal identification plates the inside of the cab is as pristine as the outside **Middle:** Looking from inside the cab the engine's bonnet cover is everything that you would expect from such a restoration, even down to the chrome protection cover caps **Right:** Fitted on the outside of the cab next to the boom is the excavator lifting instructions; a full set of the different instruction badges were made for the Hymac

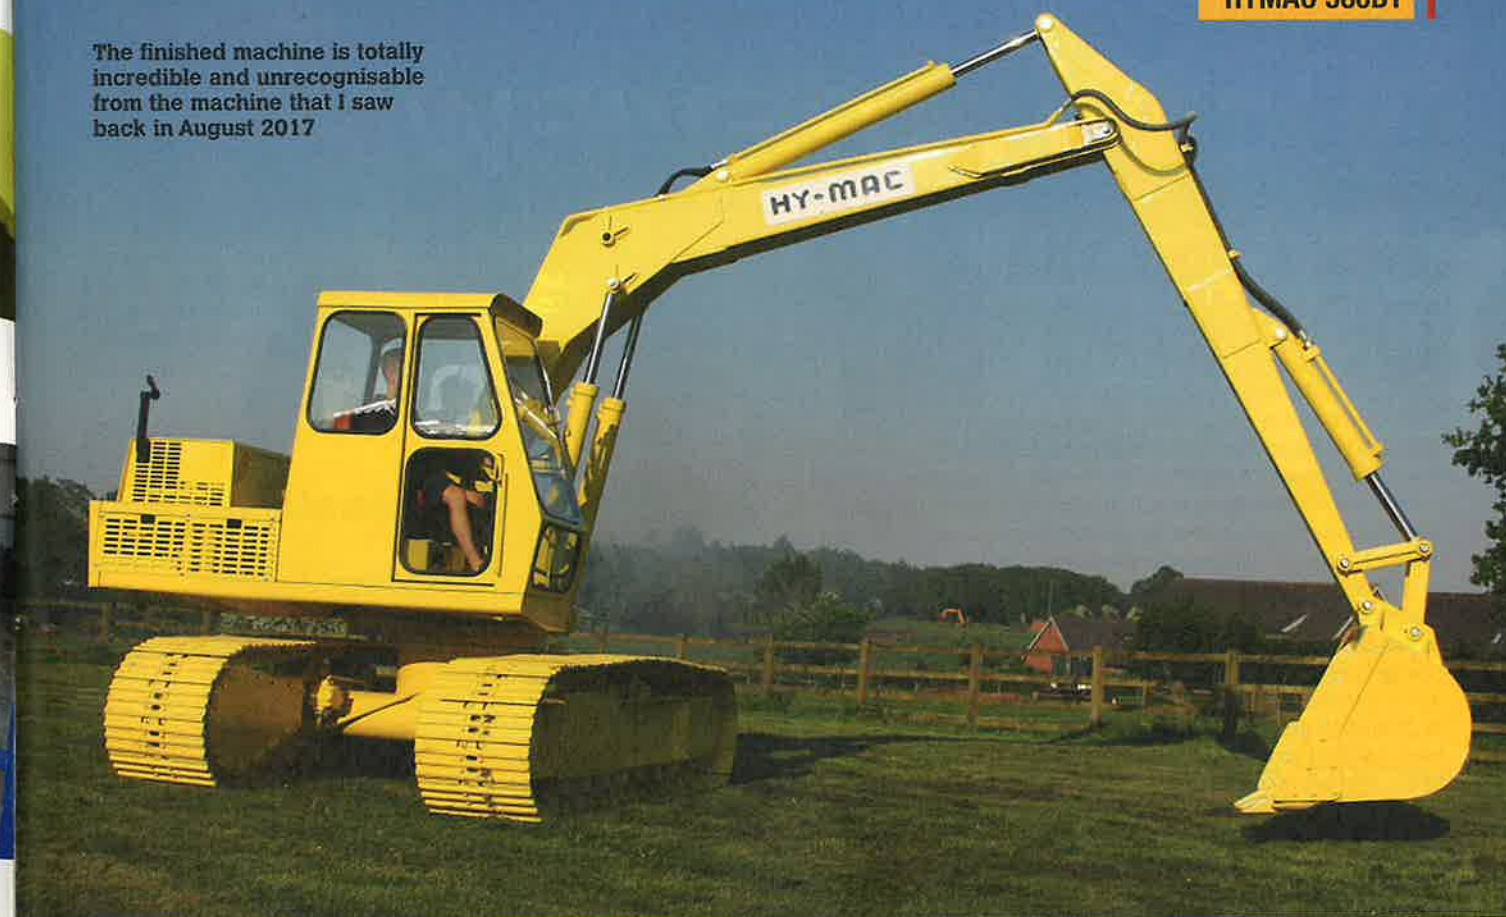
This nearside three-quarter view of the Hymac 580BT shows the high quality of the restoration job, the digger looks like new

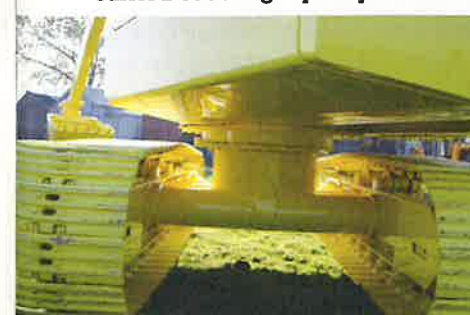
Looking at the idler end of the undercarriage, this shows the hard work that has gone into this restoration; all paintwork was touched up once again before final delivery to the customer
