JCB 930 Forklift Facelift

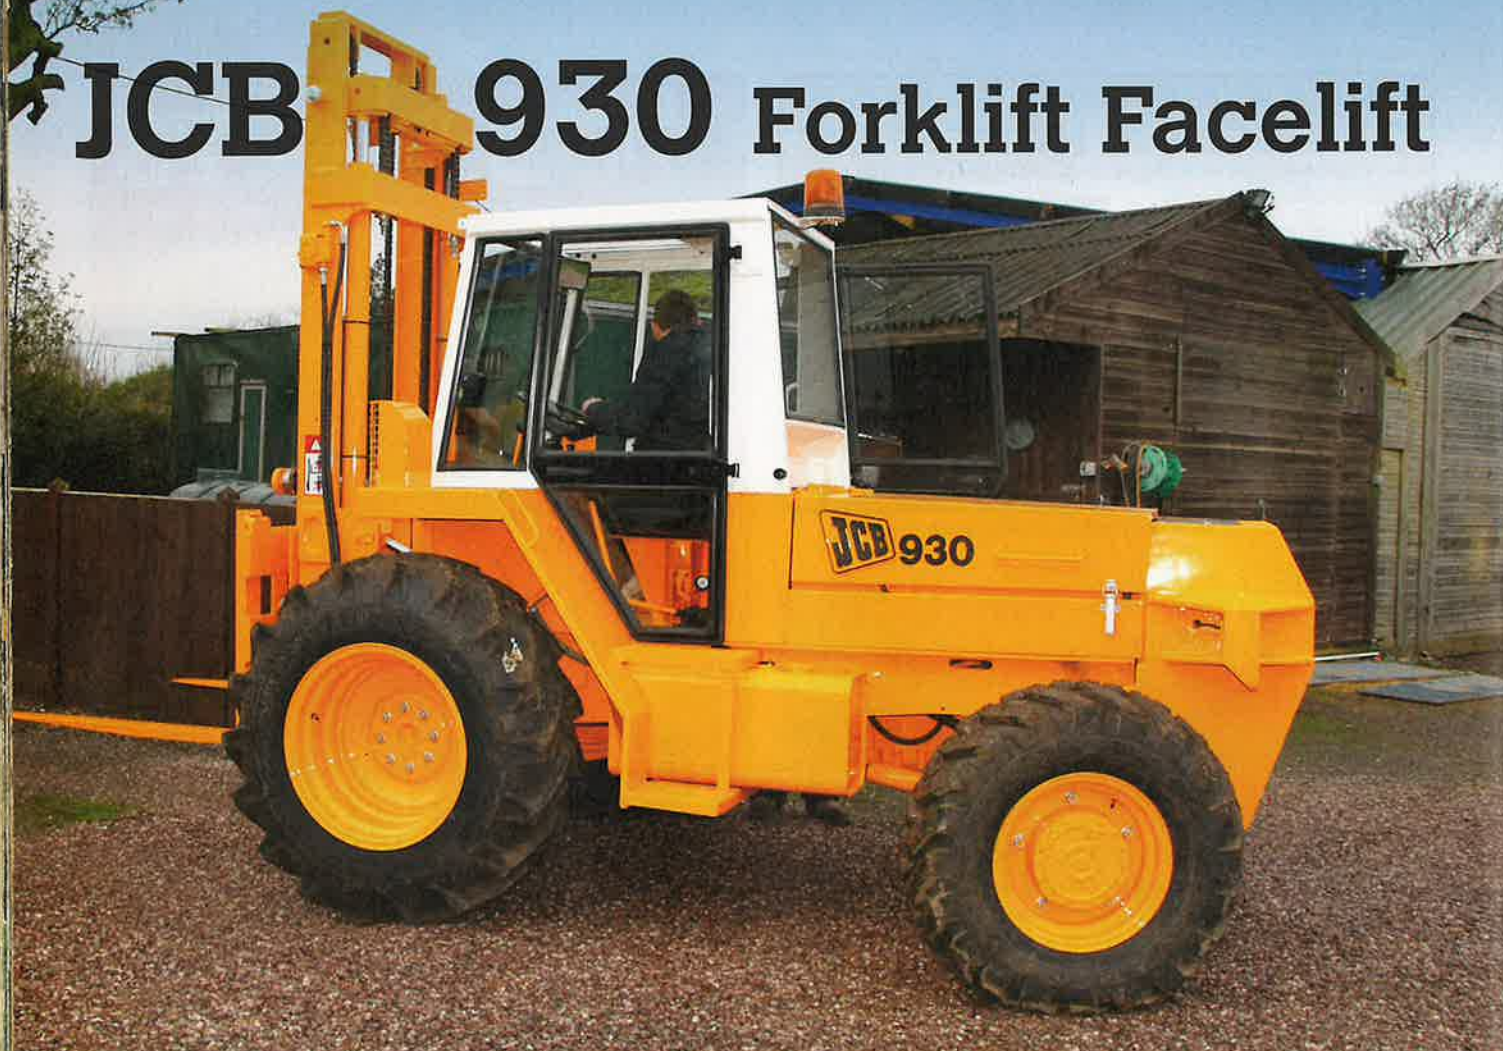
A nearside shot of the restored RTFL: once again another outstanding restoration job (Photo Jeremy Rowland)

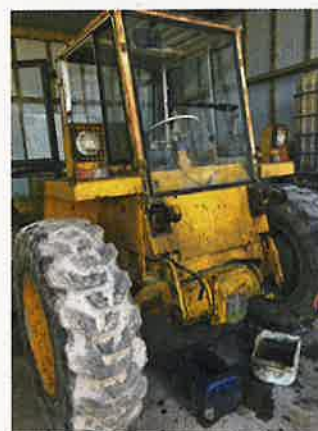
Left: The JCB 930 with the fork mast removed as the strip down of the machine commences in earnest

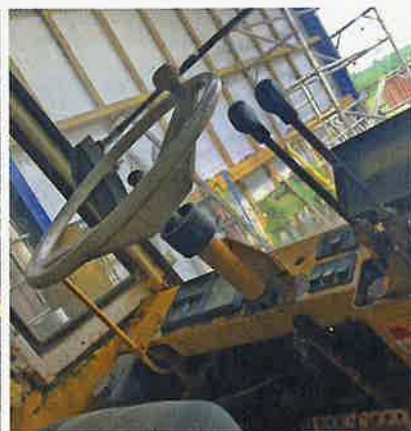
Middle: The inside of the operators' cab as received - although the cab retains all its component parts it looks rather time worn Right: An offside shot of the partially stripped RTFL showing the cab and engine covers removed (Photos Julian Carder)

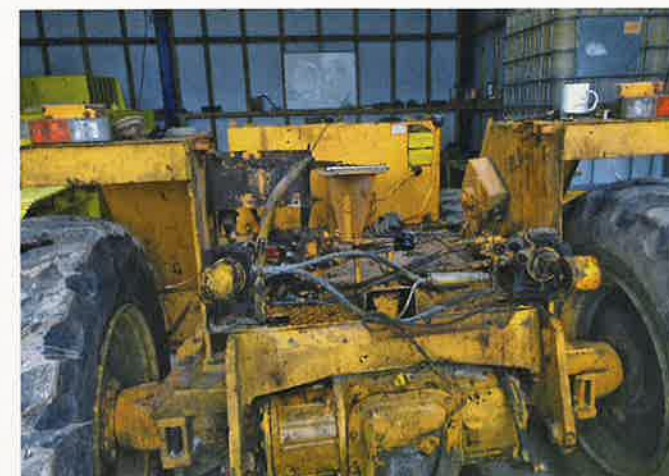
◀ This frontal view shows the progression of the strip down; the main hydraulic spool valve lies on the cab floor while the cab electrical connections can be seen resting on the nearside fork tilt ram (Photo Julian Carder)

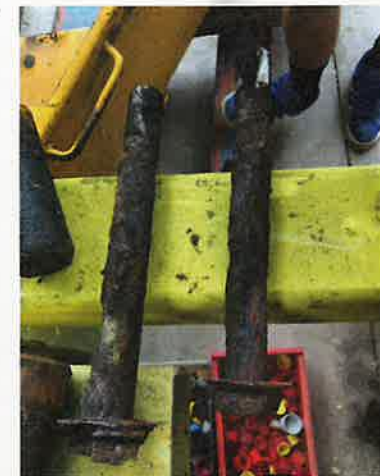
▶ Displaying the ravages of time with plenty of corrosion, the bolts that retain the drive axle were replaced with brand new items (Photo Julian Carder)

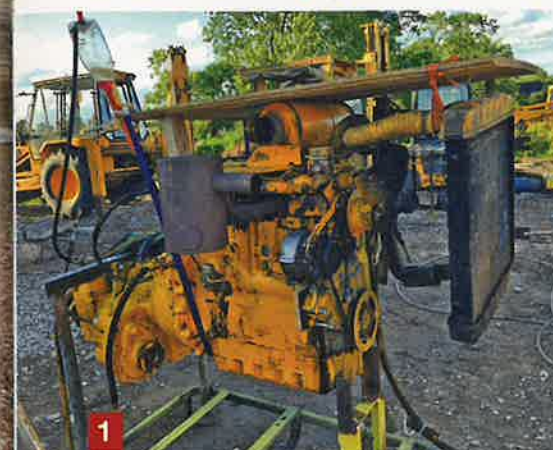
1: The engine and transmission unit mounted on a stand with a temporary fuel feed for testing; these did not require much attention short of cleaning down and painting 2: Hydraulic rams and main spool valve cleaned down ready for reconditioning and painting 3: The partially stripped mast; numerous roller bearings were replaced on the mast, the main lift rams were fully reconditioned, the lifting chain was not worn beyond its safe limit (Photo Julian Carder) 4: The bare chassis shot-blasted and given a first coat of primer. (Photo Julian Carder)

corroded, so these were stripped and repaired. The forklift's lifting mast was removed then completely disassembled, there are around a dozen or so roller bearings that support the mast sections and these were replaced with new bearings. The hydraulic rams were all refurbished along with the control spool valve block. The engine was sound as was the transmission, both of which required no mechanical work.

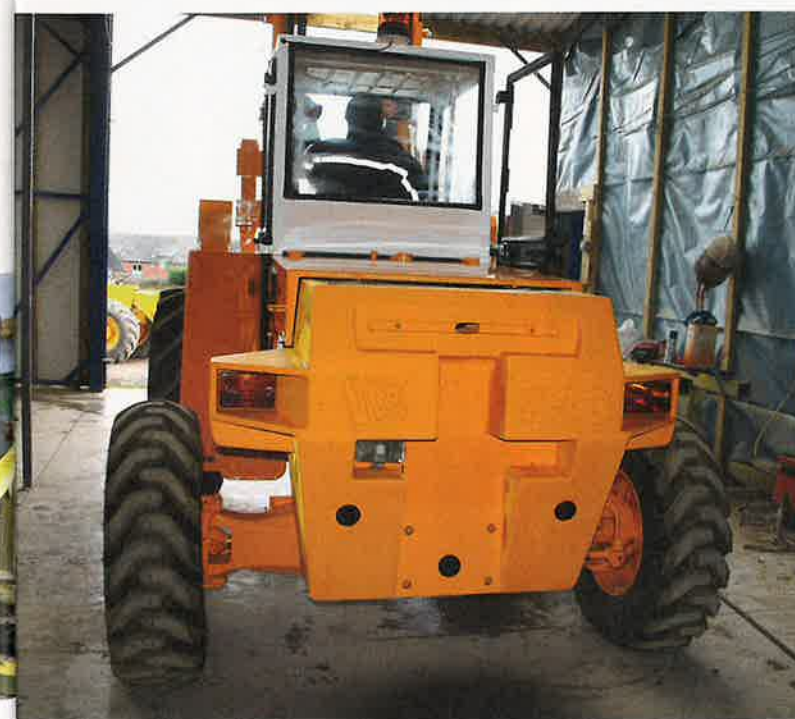
Reborn, the RTFL is now complete; note the reversing light mounted in the machine's counter weight (Photo Jeremy Rowland)

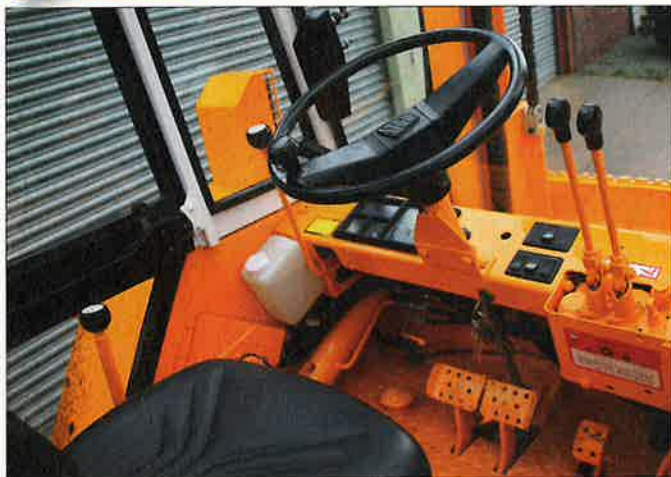
Peering into the refurbished operators' cab the machine looks as good as the day it first rolled off the JCB production line

loom which is essential when carrying out a full restoration. New lights were fitted and the operators' cab received the full works with the refurbished cab seat looking like new. All the plates, badges and stickers to match the restored cab, to finalise what I am sure you will agree with me is another superb restoration. As ever my thanks go to Julian Carder for his assistance and provision of some of the photos in this article. **CPM**

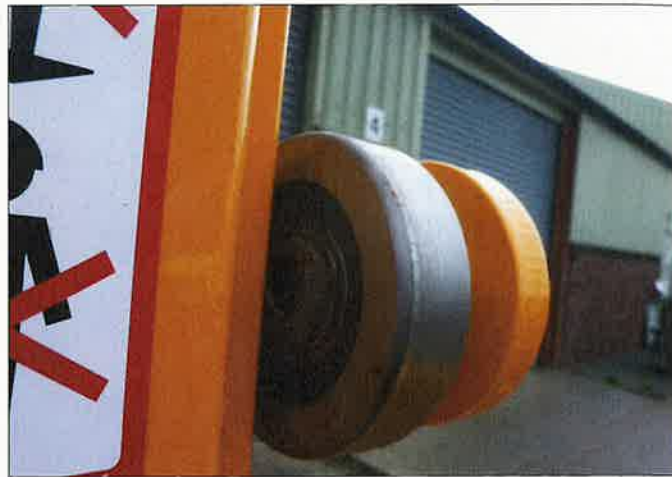
One of the many supporting roller bearings that were replaced on the forklift's mast. (Photo Jeremy Rowland)

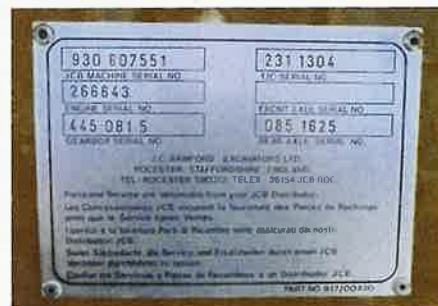
The JCB 930's serial numbers all marked on a new plate adds a nice touch to the restoration (Photo Jeremy Rowland)
