# BITS 'N' PIECES

Jeremy Rowland talks to Julian Carder about a box of bits that he turned into a JCB Mk1 Major Loader

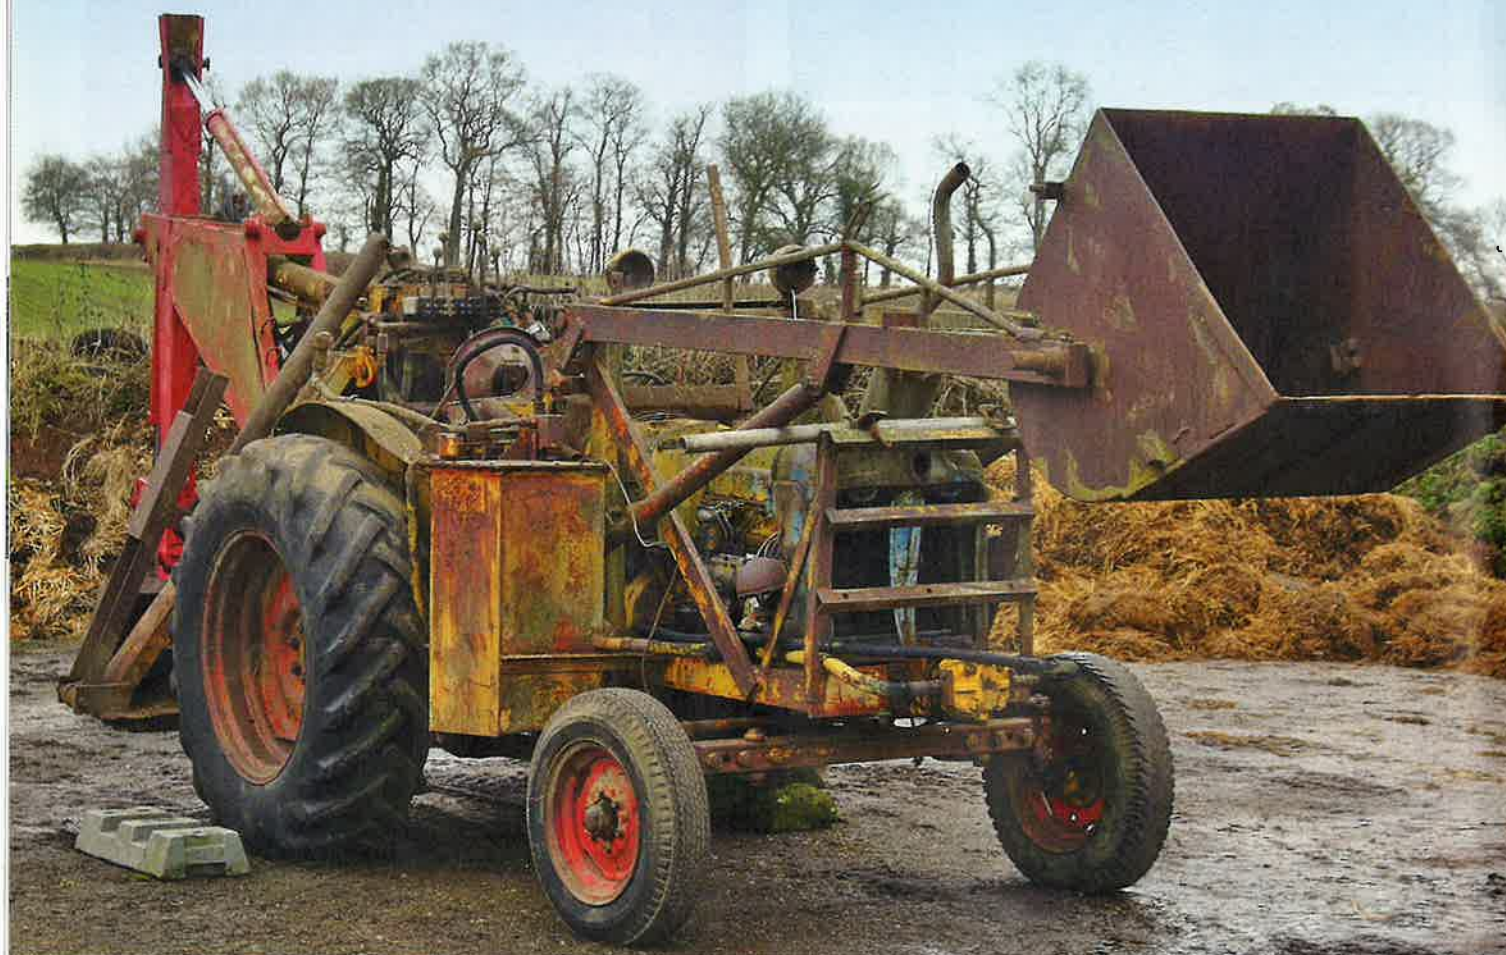
The JCB Mk 1 Major Loader as originally acquired before disassembly; the digger was in need of much TLC. (Photo courtesy of Julian Carder)

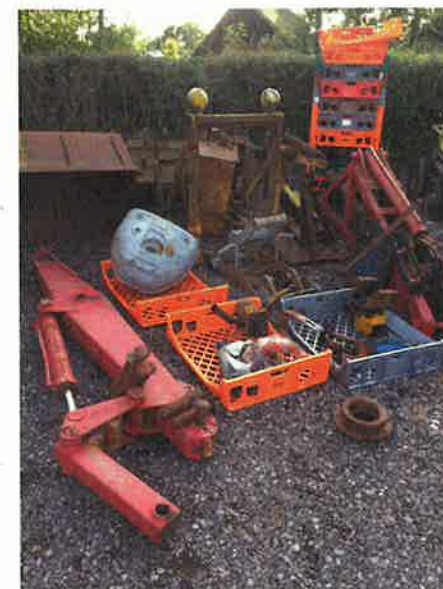
▲ The 'A' frame for the mounting of the digger's backhoe; much work was completed to bring this back up to a high standard of repair.

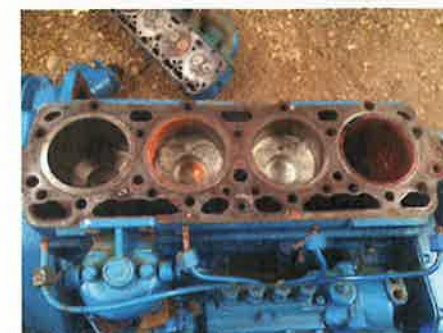
The rebuilt engine reveals the cause of seizure, which was water ingress; it is crucial to protect petrol and diesel engines' exhaust and intake systems from the ingress of water where they may be stored outside over a long period of time.

One item that should have required no attention was the tractor's engine which had already been rebuilt; however, it was totally seized and removal of the cylinder head revealed that ingress of water had caused considerable damage to the unit, making it an unviable prospect. Another

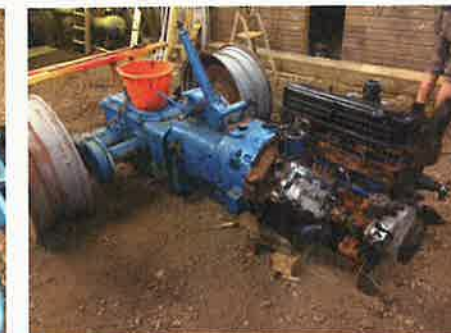
The replacement engine fastened to the transmission; the bare essentials of the machine are starting to take shape.

engine was located for the digger which was then married up to the transmission; another nose cone bonnet was acquired and fitted to the machine.

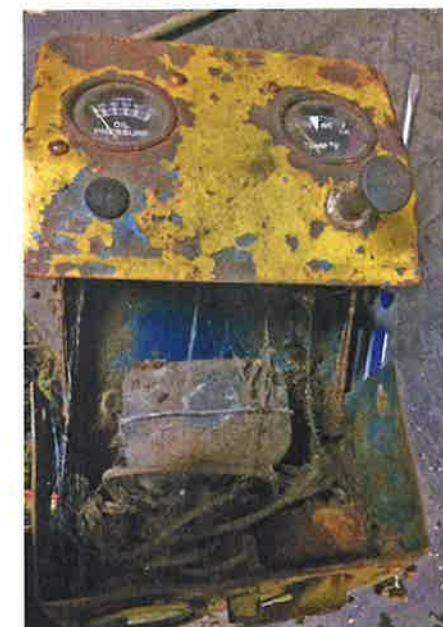
The rust and cobwebs tell their own story of decay in this photo of the digger's control console and fuse box.

The JCB Mk1 Major Loader was completed with new lights and replacement of the wiring loom.

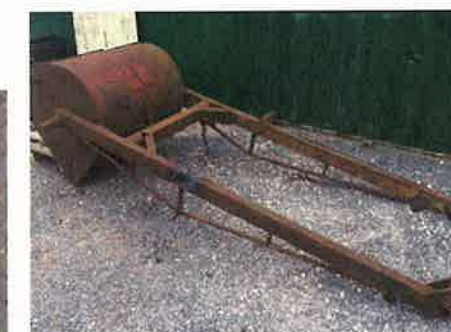
Work has commenced on the loader arms, which required much attention.

The fabrication work was the first issue to be tackled, with the old bosses being cut out of the loader arms and new ones being welded into place; unfortunately, half of the front end loader was beyond repair with a new section being fabricated. The backhoe was in a very poor condition: the teeth that are on the slew rack being badly worn, these were welded up then recut. The hydraulic spool valve block for the backhoe was seized up: this block is very heavy and required two men to lift it; it was stripped then sent away for repair. The repair to this spool block involved machining it out, then re-chroming it, then grinding it back to the original size; this valve block proved to be problematic and when it was fitted back on to the digger it did not work - the problem turned out to be an issue with the cross tubes being fitted incorrectly.

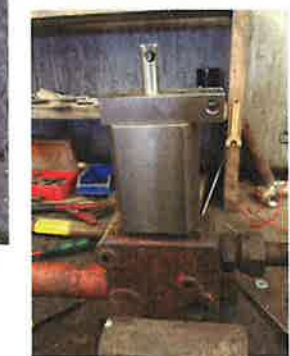
◀ The new control spool valve that was made to replace the missing item; this valve control the raising and lowering of the Major Loader front shovel.

Julian found that the hydraulic spool valve that controls the Major Loader arm had been lost: with little chance of locating a good second-hand one, the only option was to get a new one made; this was done using a borrowed one as a sample part.

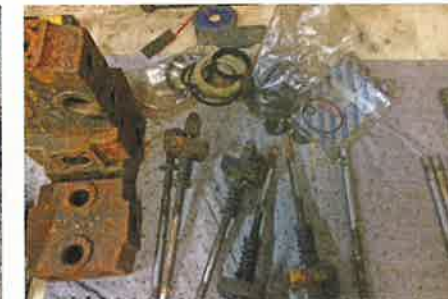
Stripped for repair is the hydraulic spool valve for the backhoe; the valve was seized and required much work to restore it to work once more. (Photo courtesy of Julian Carder)

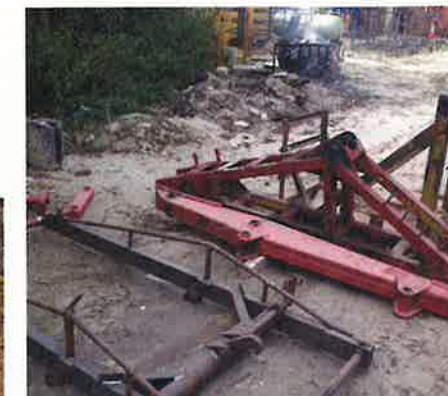
The digger's loader arms, boom and dipper arm were cleaned prior to restoration work commencing on them.

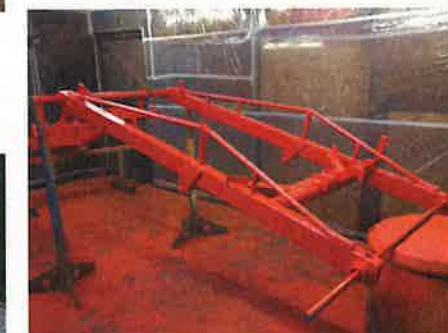
Now the worn bosses and rotten parts have been replaced the painted loader arms look unrecognisable from their former state. (Photo courtesy of Julian Carder)

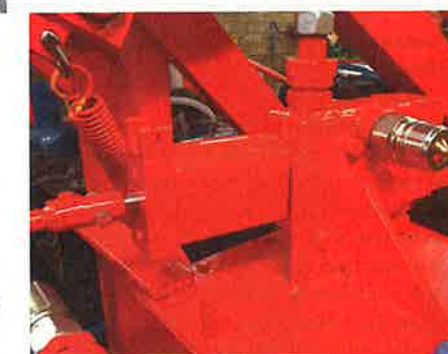
The new front loader spool block fitted to the machine; Julian was lucky in having access to a borrowed part that enabled him to have this valve made to that pattern.

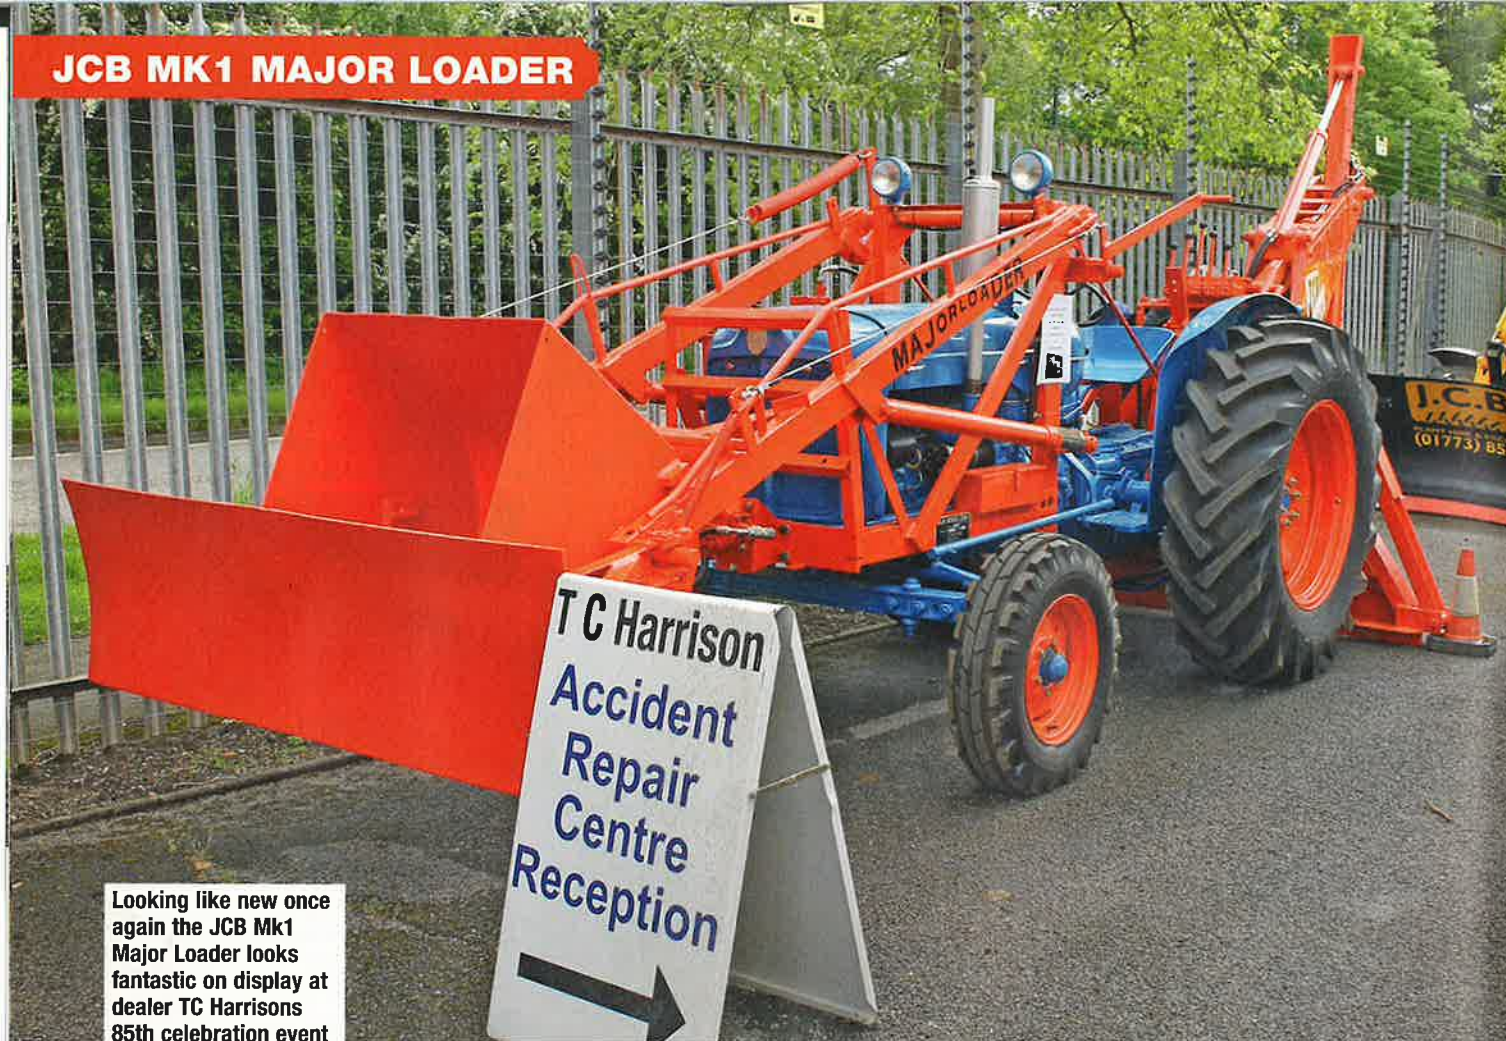
Looking like new once again the JCB Mk1 Major Loader looks fantastic on display at dealer TC Harrison's 85th celebration event

This rear view of the digger loader shows the early development of the backhoe; when in use the machine is stabilised by the 'A' frame which is hydraulically lowered to the floor. Also on display at the event was JC Balls' JCB Mk1 which can be seen in the background of this photograph

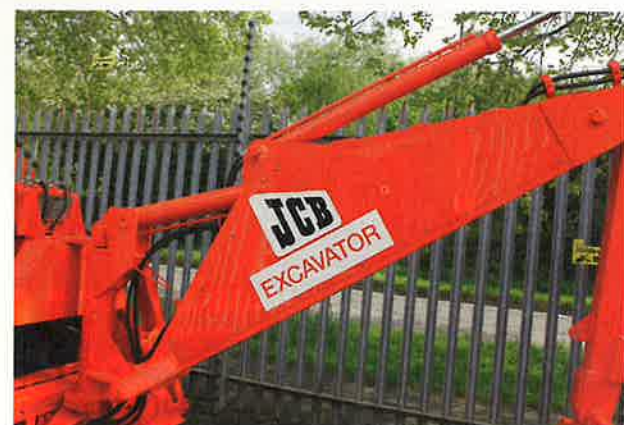
◀ This photo aptly displays the high level of the restoration with the new side plate on the left side of the boom, complete with the JCB emblem; to the bottom left of the photo you may be able to make out the repaired rack that slews the backhoe

The boom was in a corroded condition but it was salvaged and new side cover plates were fabricated and fitted; the

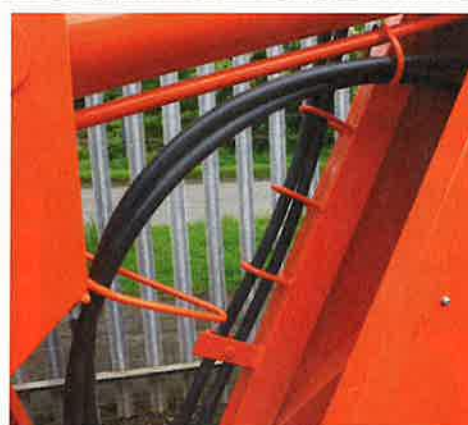
► Note the flexible hydraulic hoses are secured by simple welded steel loops

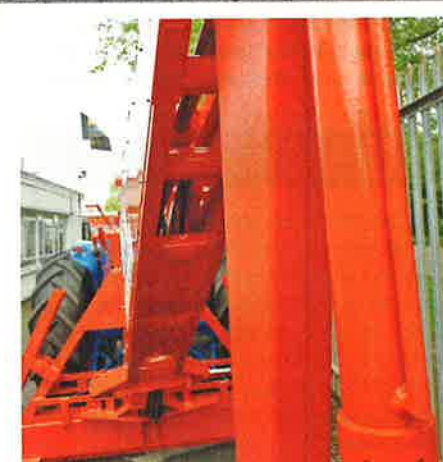
The boom hoist ram can be seen here inside the main body of the boom: all of the hydraulic cylinders were rebuilt and new flexible hydraulic hoses were fitted throughout the machine

hydraulic rams were rebuilt and new hydraulic hoses fitted.

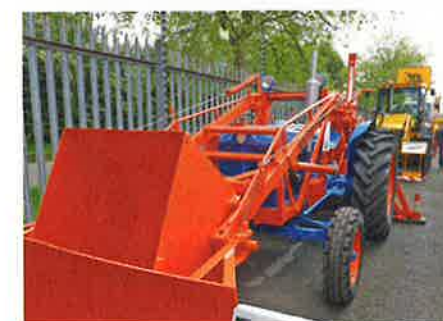
◀ The JCB Mk1 Major Loader was Joseph Bamford's first real backhoe loader. The digger may look very simple, but it was the foundation of what has become a huge multi-national company and one whose digger loaders still lead the way

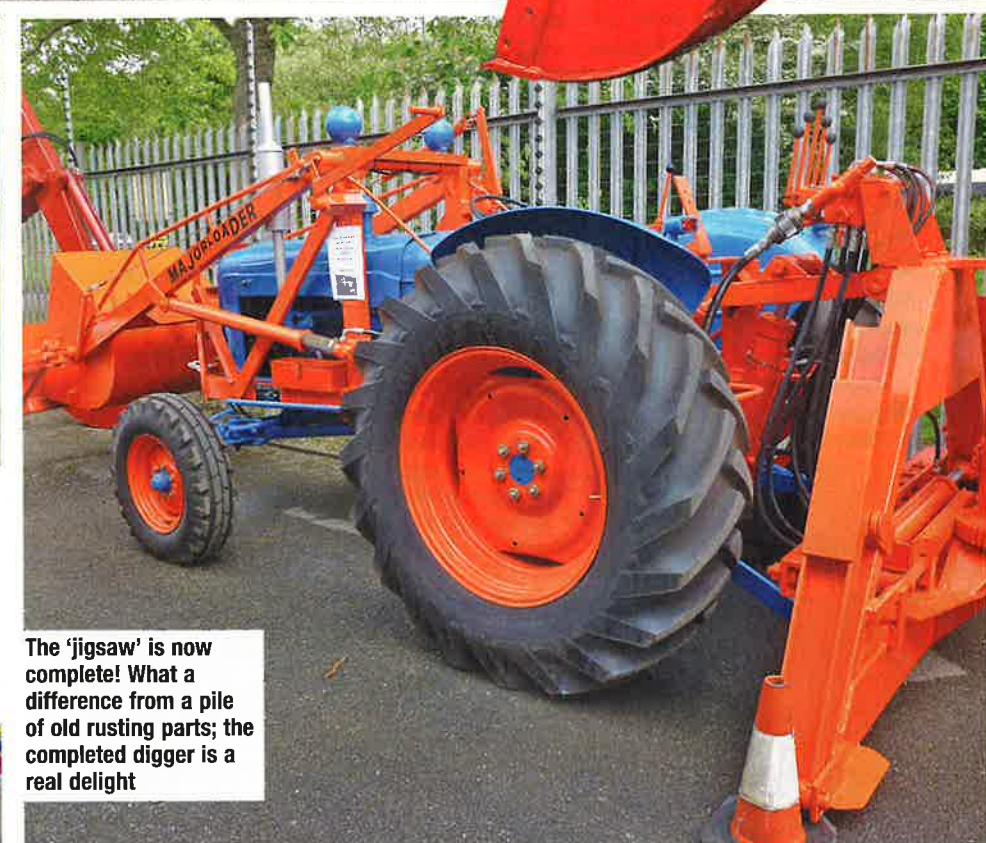
The 'jigsaw' is now complete! What a difference from a pile of old rusting parts; the completed digger is a real delight
