SHAWNEE POOLE — SHINES AGAIN —

Jeremy Rowland has the story of Julian Carder's restoration of this Rhodesian-designed hauler for Paul McGuigan

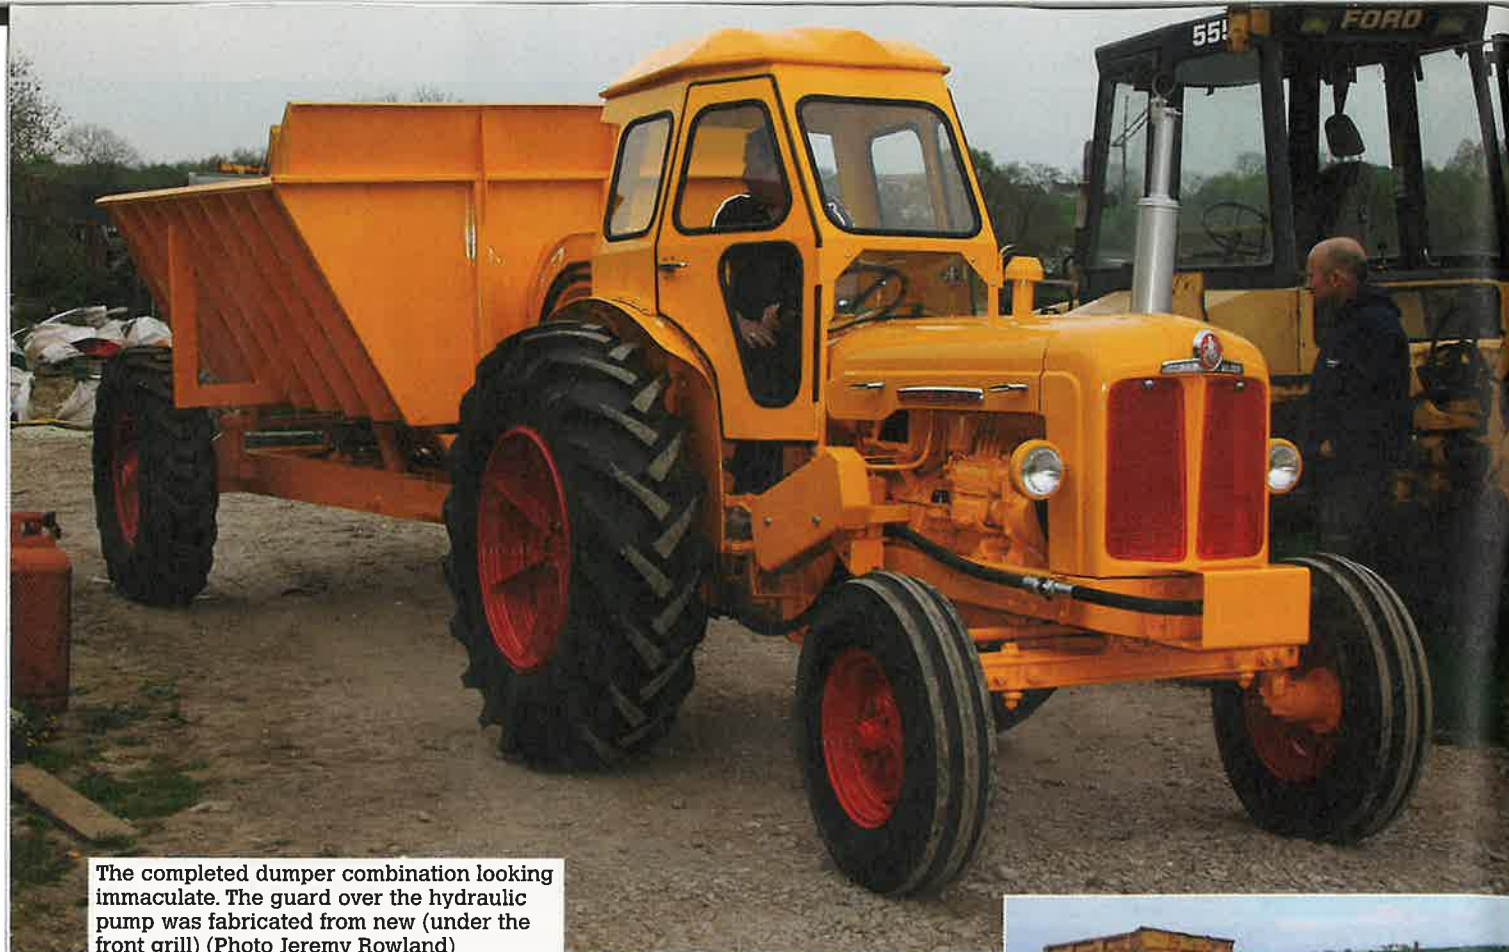
The completed dumper combination looking immaculate. The guard over the hydraulic pump was fabricated from new (under the front grill) (Photo Jeremy Rowland)

repairs were needed to the 'S' cam brake actuators, one of which had also been fitted incorrectly by a past owner. Like many accomplished digger loaders, the Shawnee Poole utilises a hydraulic pump driven off the engine front pulley to power the hydraulic tipping rams; this was also refurbished and a new guard to surround it was fabricated.

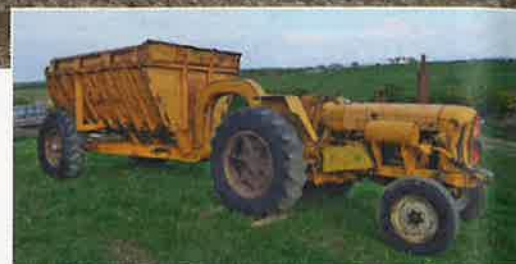
The Shawnee Poole as purchased

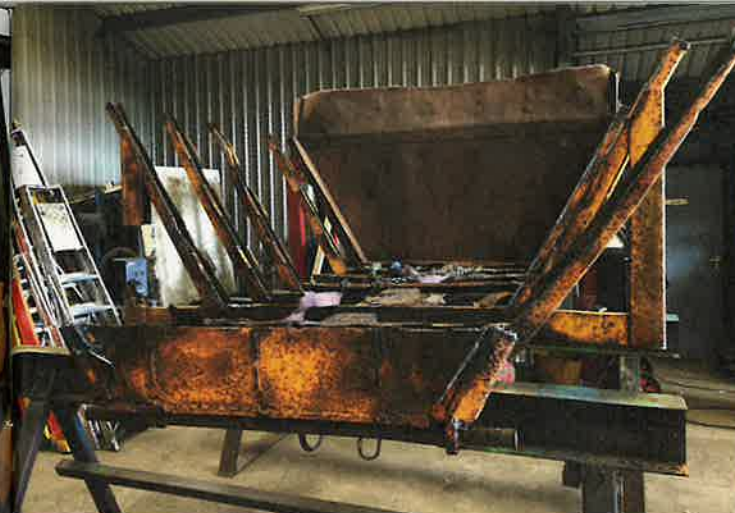
◀ The poor condition of the dumper body is evident in this photo; the bottom of the body had rotted into holes and the main support ribs and cross members were also badly corroded (Photo Julian Carder)

The dumper body proved to be rotten through with rust and was beyond saving, so once what was left of the side and bottom plates had been removed, measurements were taken to enable a new dumper body to be fabricated. The dumper chassis was found to be in reasonable condition although the two telescopic hoist rams and damper needed to be full stripped down and refurbished. The trailer has a two-cylinder air brake system, the cylinders of which were in a poor state of repair as were the brakes themselves. These were totally stripped down for repair, in addition

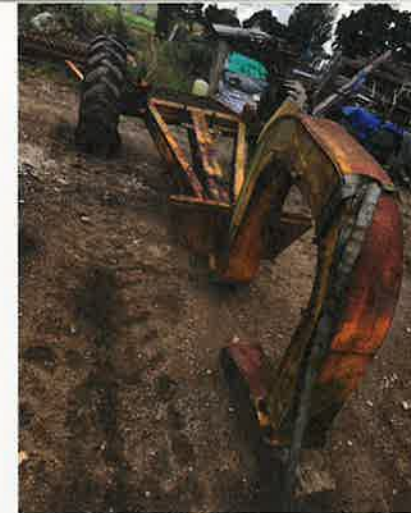
▶ Stripped of the tipping body the chassis of the dumper was in much better condition, although much work was required to renovate the brakes. The 'goose neck' part of the hitch can be clearly seen here (Photo Julian Carder)

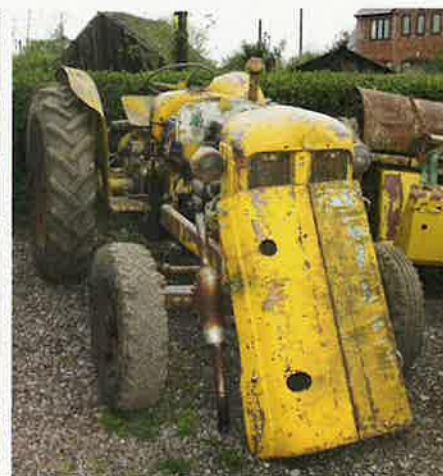
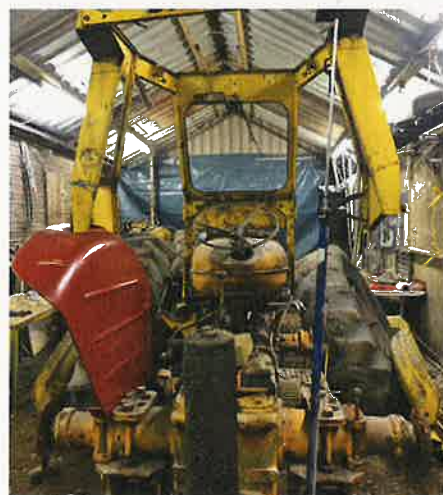
Left: The air compressor, hand valve and release valve removed ready for reconditioning
Right: Fully rebuilt and waiting to be refitted to the Fordson tractor, the air compressor for the braking system is belt-driven directly off the transmission (Photos Julian Carder)

Compressed air for the air braking system is provided by an air compressor driven directly off the side of the clutch/transmission case; this compressor was also fully refurbished along with the control valves. The rebuild naturally comes complete with the nice little touches that make these restoration jobs stand out, in this instance Julian already possessed a pair of genuine Shawnee Poole plates which have been fitted to add that authentic touch to the dumper. My thanks as always goes to Julian Carder for some of the photographs and information in this article. **CP&M**

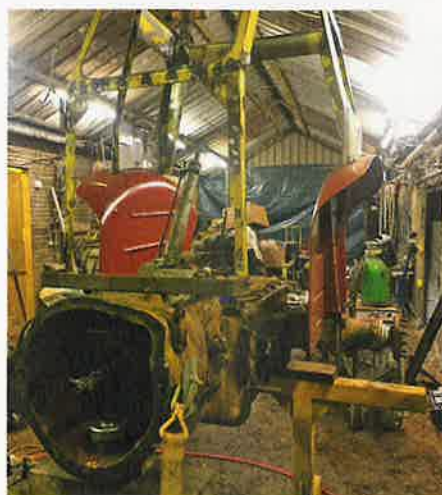
Looking rather forlorn is the donor tractor that was purchased for the cab; without any drawings of the original cabs available or even good clear photos, the cab presented a challenge (Photo Julian Carder)

The dumper as purchased by Paul did not have an operator's cab fitted. Paul wanted a cab on the restored machine as his grandfather's machine had one fitted. This presented a problem for Julian in as much as there were no drawings available of the original cab. Another Fordson Major tractor which had a cab fitted was obtained to use for spare parts. The cab from this old tractor had seen better days, the plastic roof was paper thin where it had decayed over time, this was repaired with glass fibre and the repaired frame was secured to the two new wings already fitted to

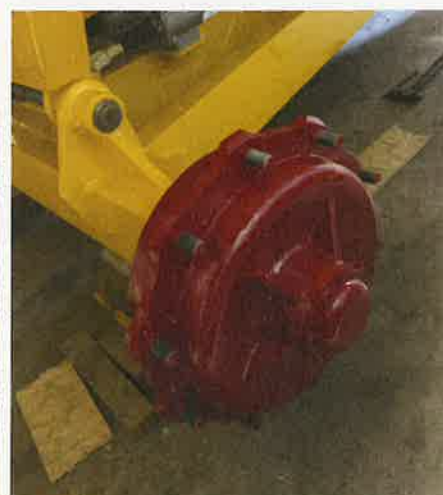
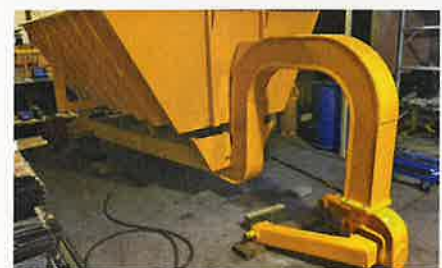
Left: The left-hand new wing has been fitted into position and the cab is being jugged ready to get it into position; note the Poole hitch that can be seen here bolted to the underside of the tractor's drive axle
Middle: The repaired cab frame sits on the two newly fitted wings
Right: The trailer's offside brake drum and hub assembly refitted and painted as the restoration progresses (Photo Julian Carder)

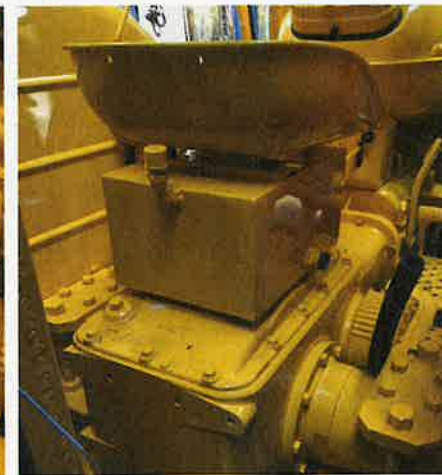
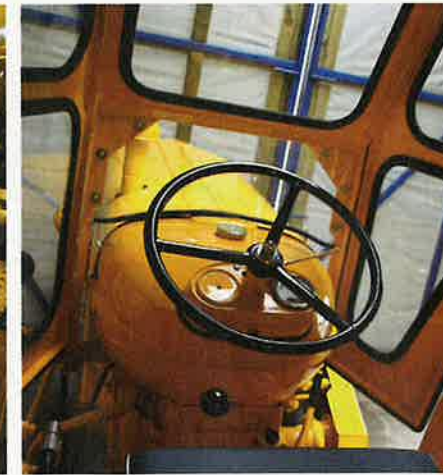
Left: The newly designed and fabricated hydraulic oil tank rests in position; the driver's seat will later be attached to the top of this tank. The tipper control spool valve is visible in the top left of the photo
Right: Finally, the hydraulic oil tank is finished with the driver seat fastened to it (Photos courtesy of Julian Carder)

oil tank was designed by Julian using cardboard templates to simplify the design process. After much deliberation it was decided that the newly fabricated hydraulic oil tank would sit underneath the driver's seat, while the compressed air reservoir would be fitted in between the two main support members of the trailer's 'A' frame chassis.
