STEELFAB

160/180

Jeremy Rowland reports on an outstanding restoration of a loader-backhoe.

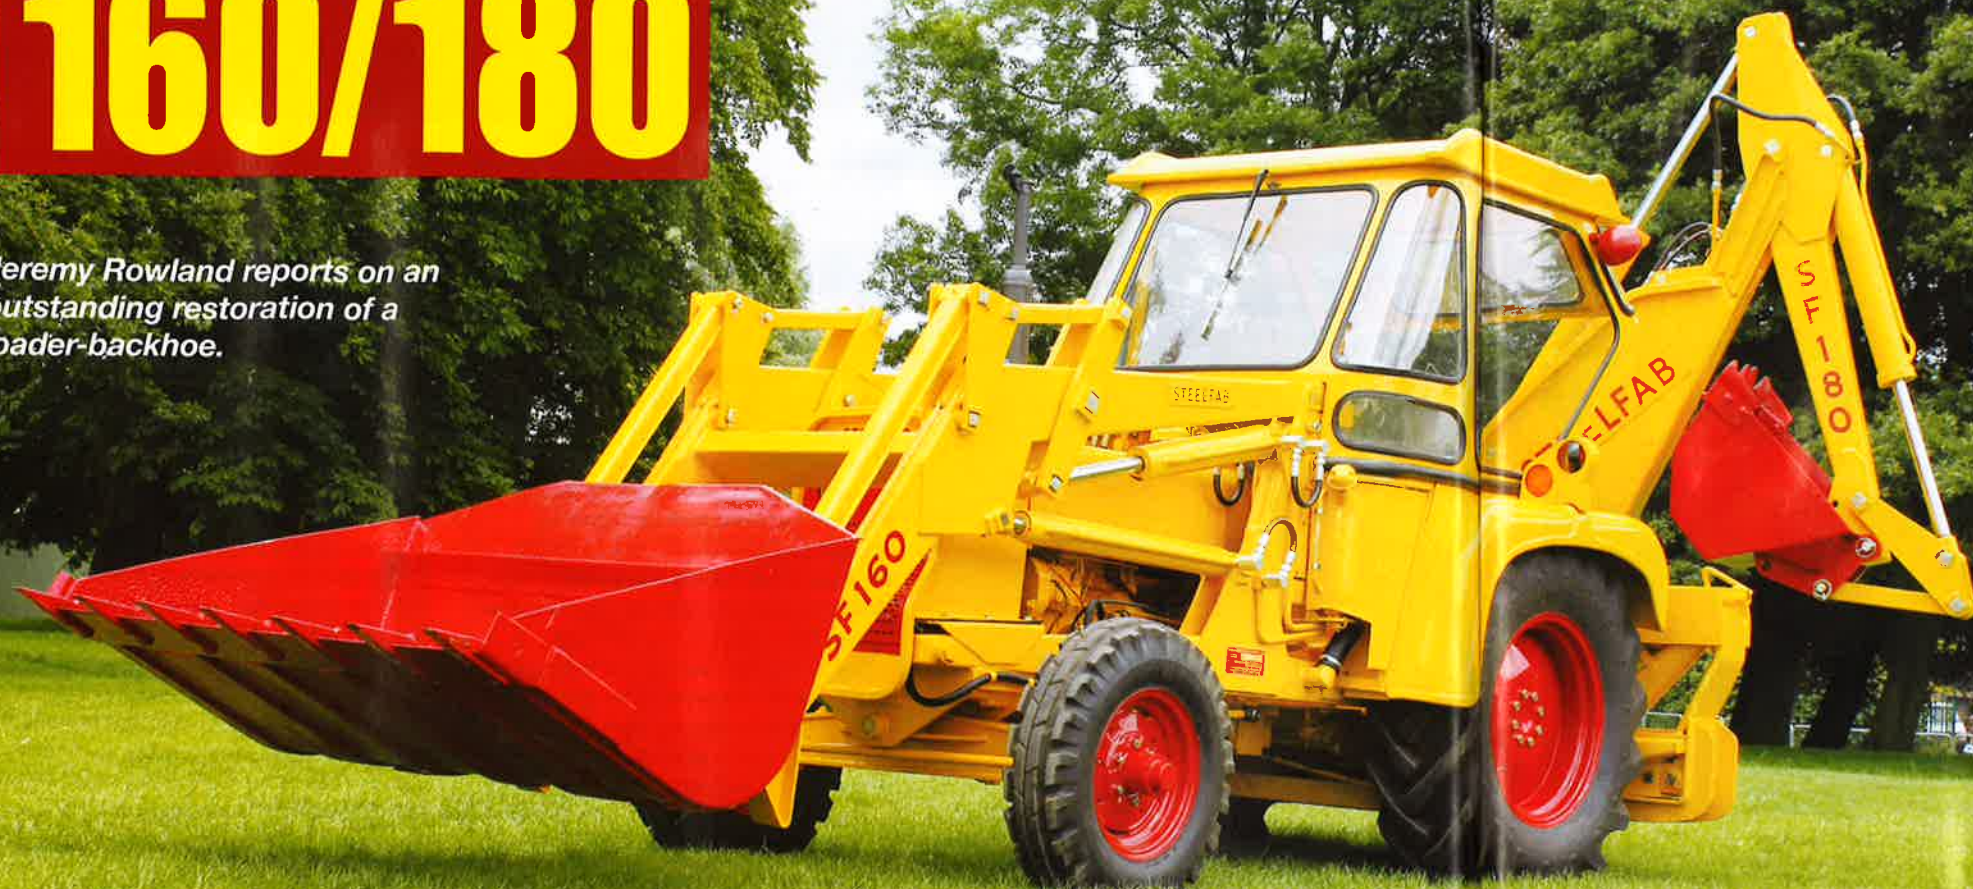
'Sitting pretty' the Steelfab 160/180 shines as it stands waiting to be moved to the allotted site area for the show. The filler cap at the front of the wing is for the hydraulic oil header tank, the black flexible hose seen in front of the back wheel joins the header tank to the chassis which acts as the main oil reservoir. (Photo: Jeremy Rowland)

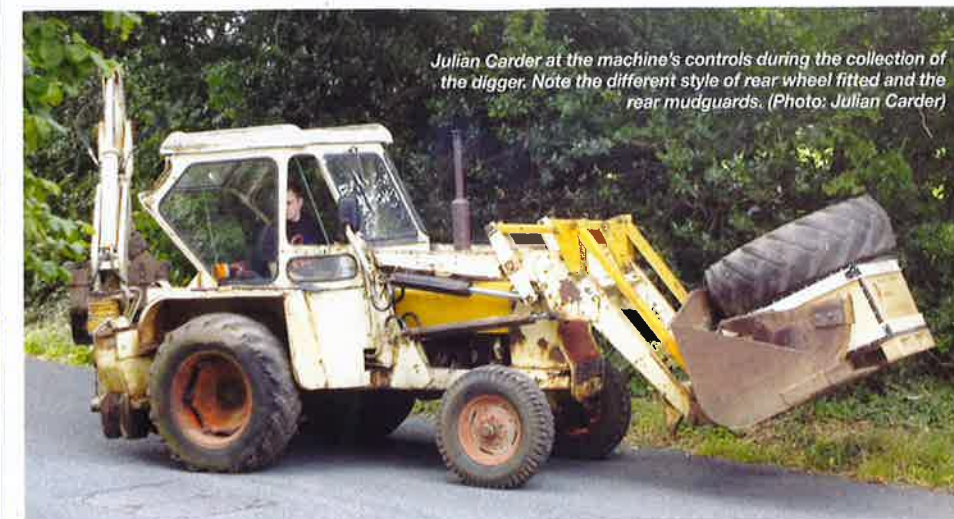
Julian Carder at the machine's controls during the collection of the digger. Note the different style of rear wheel fitted and the rear mudguards. (Photo: Julian Carder)

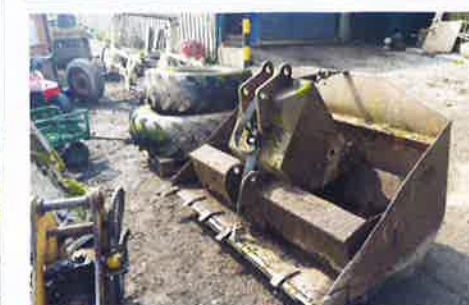
With the stripped carcass of the digger in the background, here is a shot of three of the buckets purchased for the machine. The buckets came from Devon and had been in a stream for the last 30+ years. (Photo: Julian Carder)

The original buckets for the digger-loader were badly worn and the front shovel had been cut down. Fortunately two secondhand ones were acquired. They had spent the last 30 years in a stream in Devon but once shot-blasted they proved

to be okay although new teeth were fitted along with a good used toe plate.

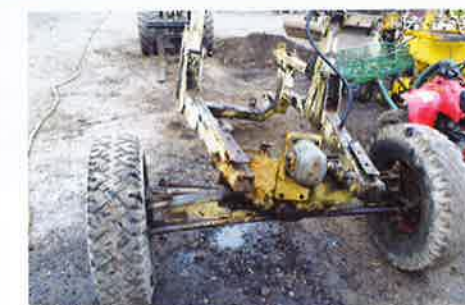
The Steelfab stripped right back to the chassis. Note the hydraulic pump which is mounted in the standard position for this type of machine at the front of the chassis; you can see that part of the diggers chassis acts as the main hydraulic oil reservoir. (Photo: Julian Carder)

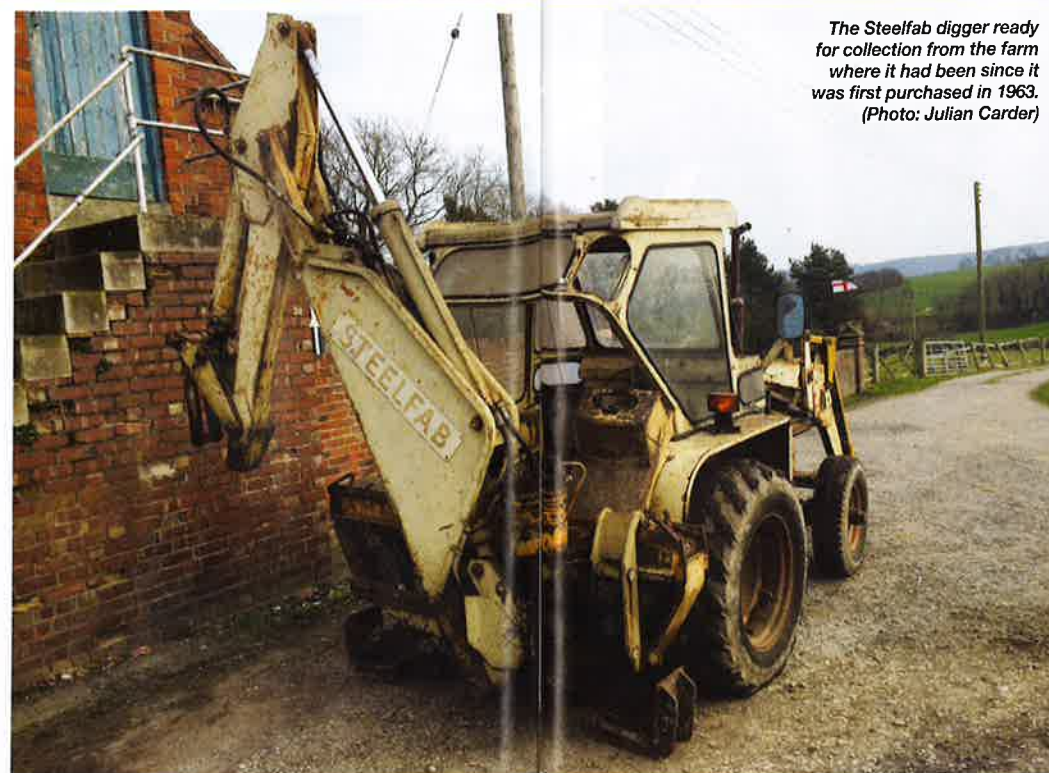
The Steelfab digger ready for collection from the farm where it had been since it was first purchased in 1963. (Photo: Julian Carder)

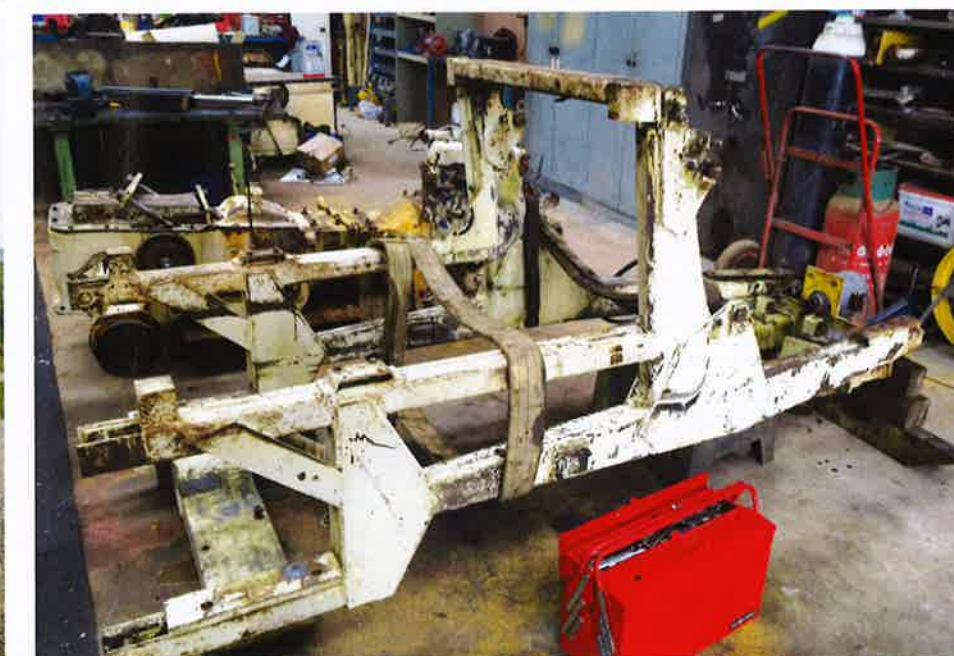
A view of the offside of the stripped chassis and skid unit prepared ready for shot blasting. (Photo: Julian Carder)

The digger was, of course, completely stripped down to enable this thorough rebuild of all of the machine's parts. Once stripped off the machine most parts were first jet washed down after which they were shot-blasted before receiving an undercoat of paint.

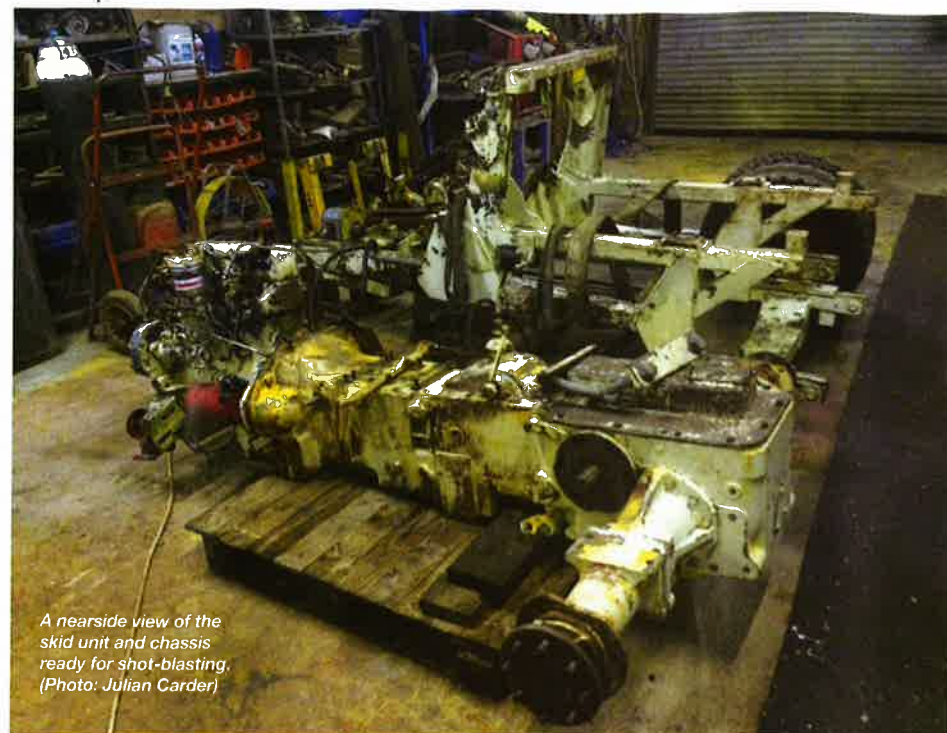
A nearside view of the skid unit and chassis ready for shot-blasting. (Photo: Julian Carder)

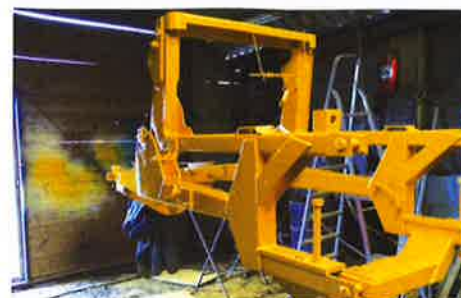
The chassis is repainted after shot-blasting. Supporting the chassis in this way enables better access to ensure that every part is evenly covered with paint. (Photo: Julian Carder)

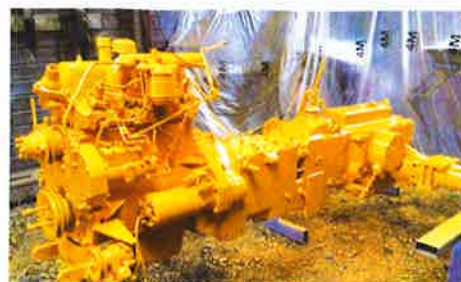
The skid unit stands re-painted ready for assembly to the main chassis. (Photo: Julian Carder)

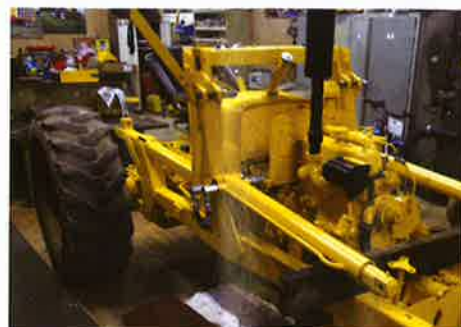
As the restoration progresses the machine slowly starts to take form once again. The re-assembled chassis and skid unit are seen along with the fuel tank, new exhaust and loader arm rams. (Photo: Julian Carder)

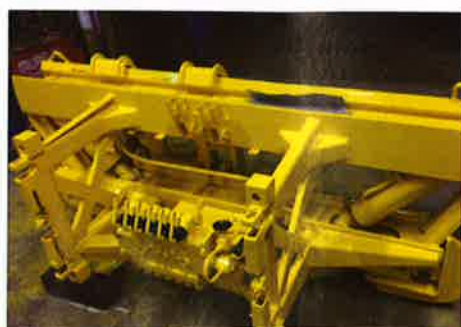
The backer frame along with the stabiliser legs and hydraulic control valve are ready for fitting back onto the digger. (Photo: Julian Carder)

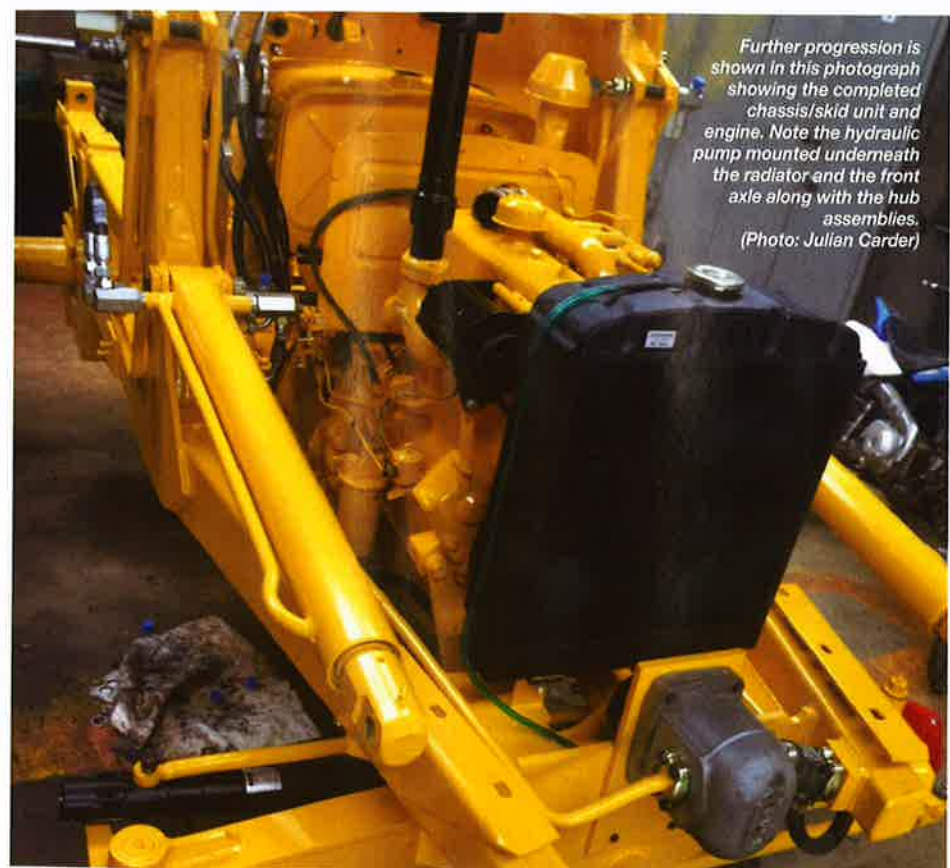
Further progression is shown in this photograph showing the completed chassis/skid unit and engine. Note the hydraulic pump mounted underneath the radiator and the front axle along with the hub assemblies. (Photo: Julian Carder)

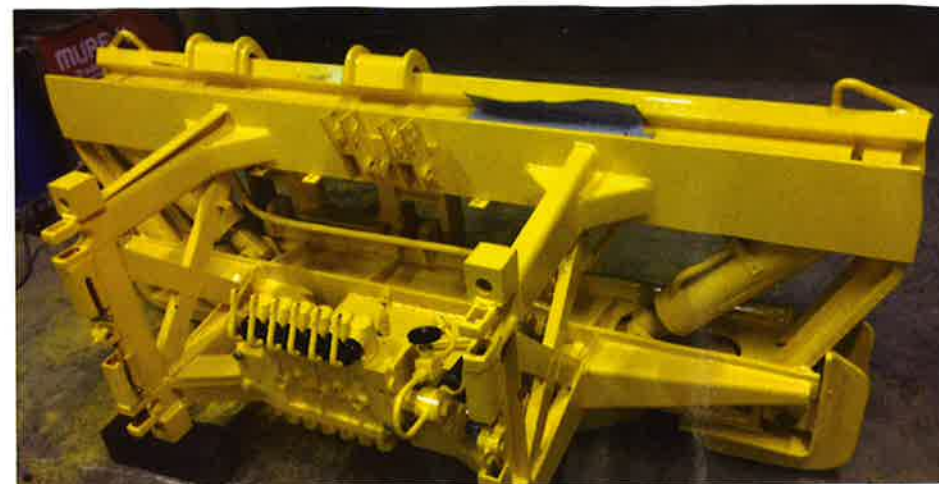
The boom and dipper arm after shot blasting are ready for painting. (Photo: Julian Carder)

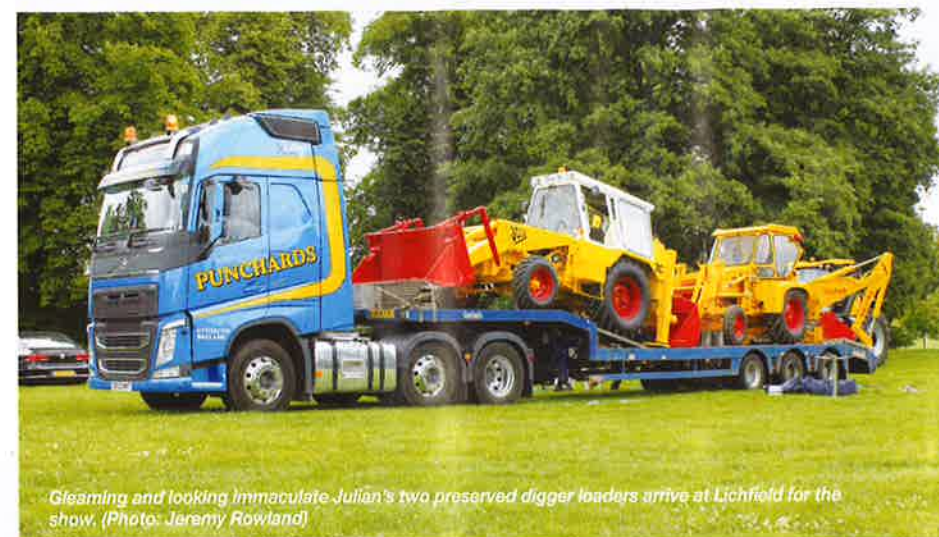
Gleaming and looking immaculate Julian's two preserved digger loaders arrive at Lichfield for the show. (Photo: Jeremy Rowland)

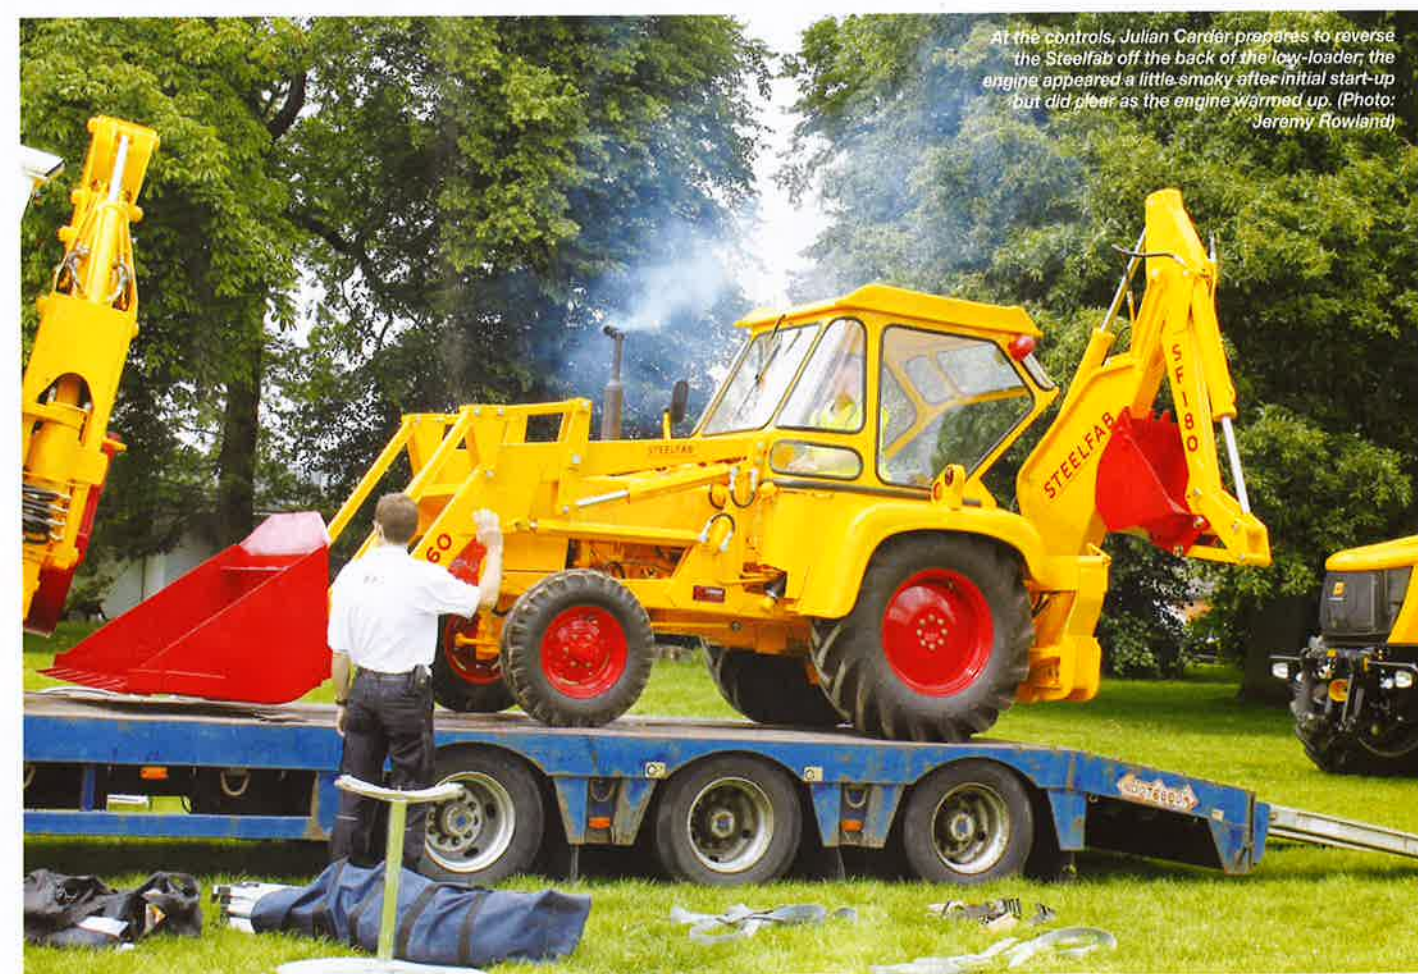
At the controls, Julian Carder prepares to reverse the Steelfab off the back of the low-loader, the engine appeared a little smoky after initial start-up but did clear as the engine warmed up. (Photo: Jeremy Rowland)

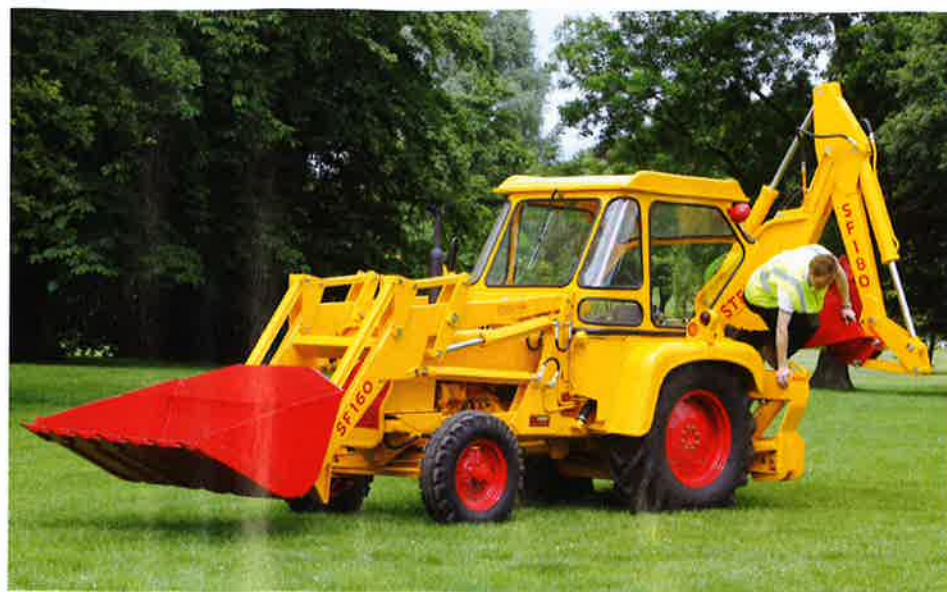
The Steelfab 160/180 has no cab doors and the machine is accessed via a partially open rear cab; the operator climbing in or out in this case next to the backacter. How things have changed! (Photo: Jeremy Rowland)

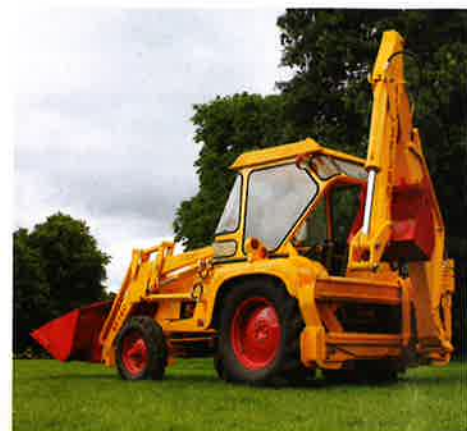
This three quarter rear photograph gives a clearer view of the cab access. The cab itself is secured by only four screw hook type fasteners. (Photo: Jeremy Rowland)

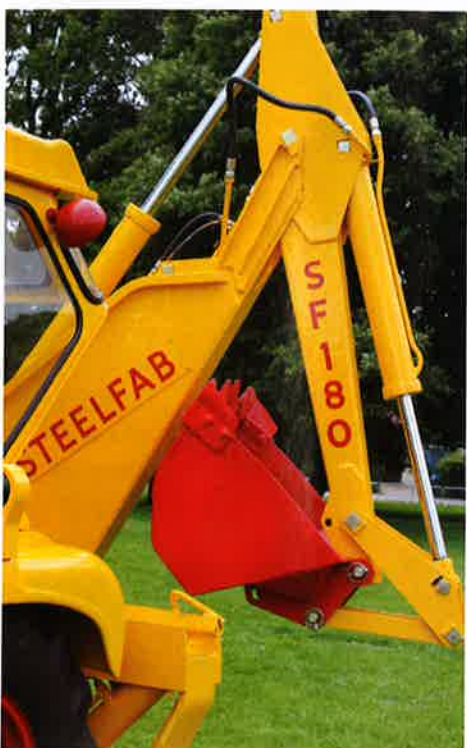
A close-up shot of the boom and dipper arm. Of interest are the square mounting linkage pins for the pivots and hydraulic rams. All of the pins on this digger have been newly manufactured. (Photo: Jeremy Rowland)

Wear in the loader arms pivots, along with the excavator arm, meant that they were bushed as required. They all had new mounting pins manufactured and fitted that were a zinc and yellow passivated finish.

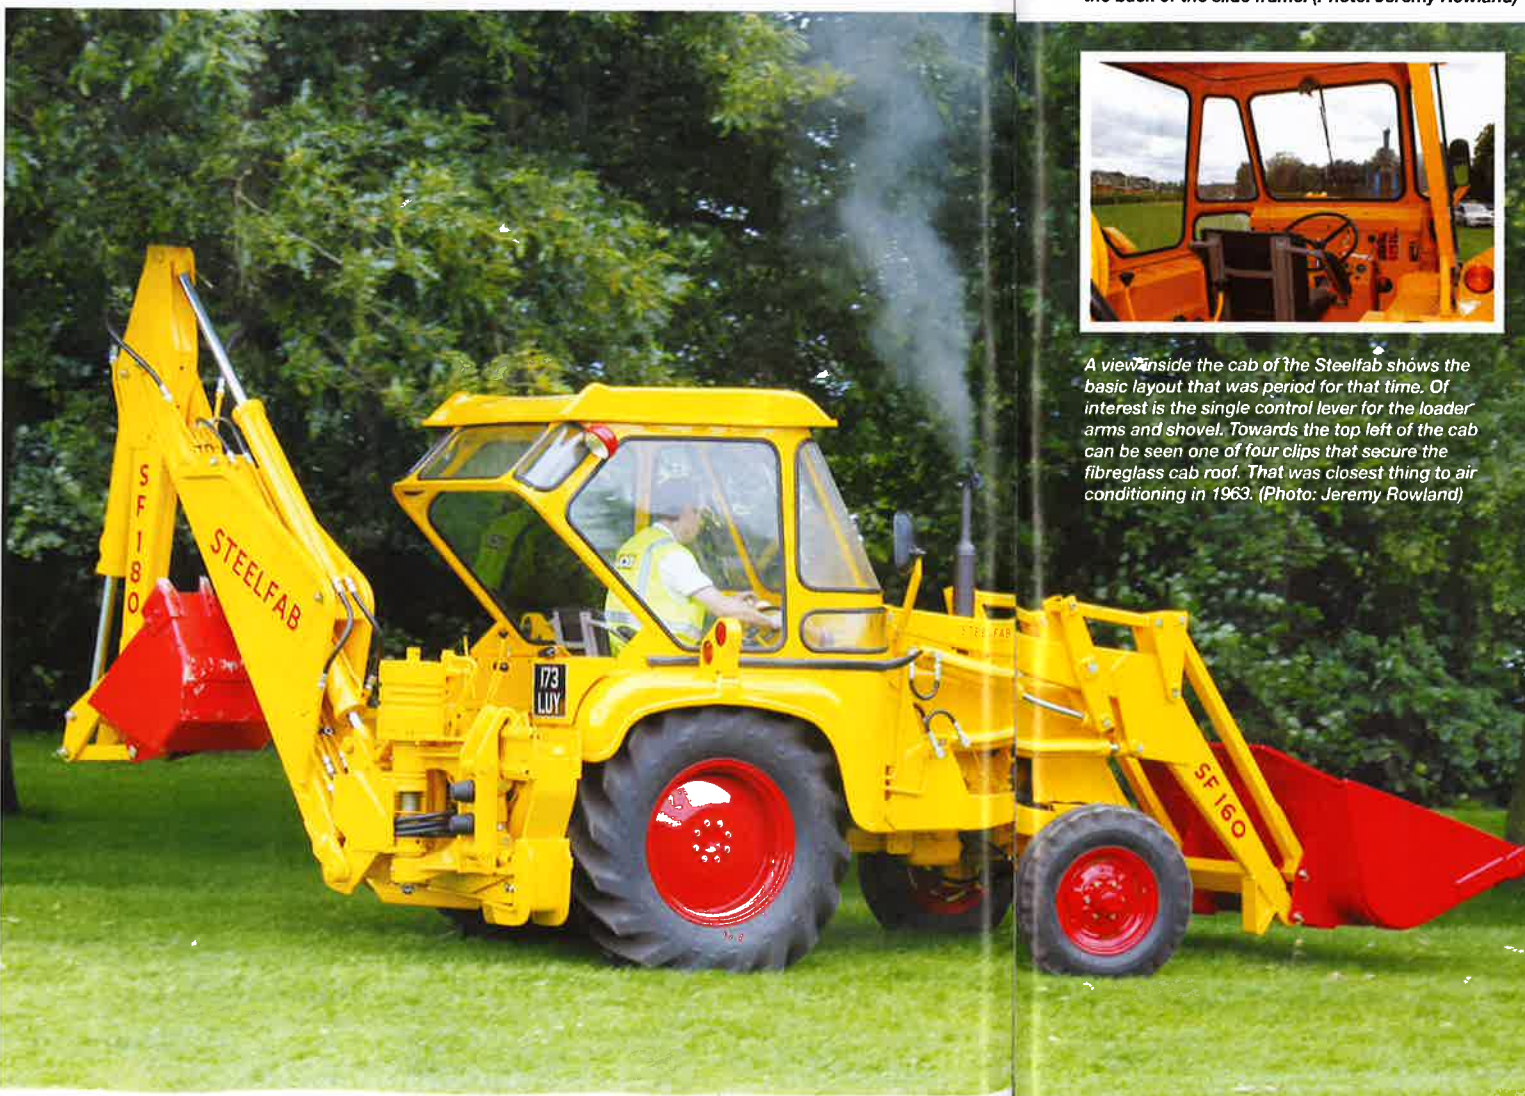
ABOVE: This view shows the digger's backacter and mounting. The rotary actuator that turns the arm is manufactured by Dowty and can be seen between two of the arms operating levers the lower part of the main shaft for this component was re-chromed. The whole arm assembly could slide along the rail and was hydraulically locked into position which was ahead of other competitors' machines at the time. Note the rubber 'bump stops' that prevent the arm from hitting the back of the slide frame. (Photo: Jeremy Rowland)

Another component that required attention was the rotary actuator pivot shaft for the machines digging arm. This was badly corroded and required grinding back then re-chroming.

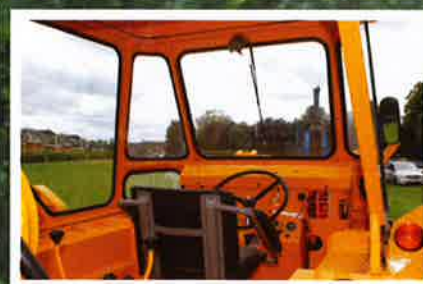
A view inside the cab of the Steelfab shows the basic layout that was period for that time. Of interest is the single control lever for the loader arms and shovel. Towards the top left of the cab can be seen one of four clips that secure the fibreglass cab roof. That was closest thing to air conditioning in 1963. (Photo: Jeremy Rowland)

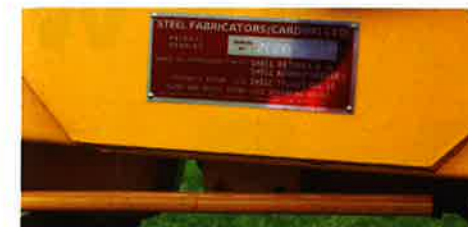
The newly-made manufacturers' plate. It's nice touches like this that really make a restoration job stand out, note the new drag link end on the steering drop arm at the bottom of the picture. (Photo: Jeremy Rowland)

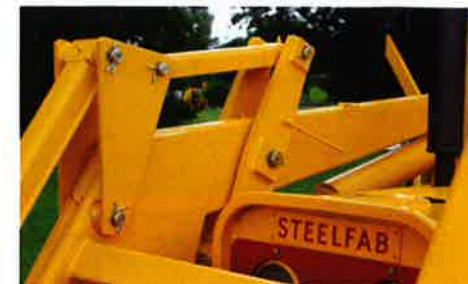
The loader arm linkages that were refurbished with new bushes and linkage pins. The linkage pins on the arms are secured only by a simple split pin. (Photo: Jeremy Rowland)

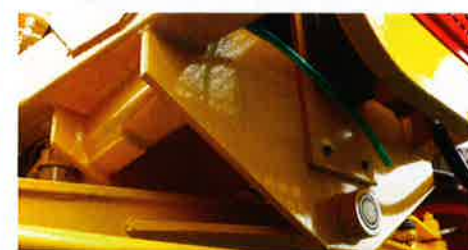
The re-bushed front axle pivot. The steering tract rod is mounted in front of the axle; this track rod required straightening prior to being refitted. (Photo: Jeremy Rowland)

The front axles pivot required re-bushing because of extensive wear, once finished the axle was ready for the stub axles and hubs to be fitted.

While the front axle was stripped the steering gear came under close scrutiny with the steering box being replaced and the steering ram refurbished, this work was complemented by the replacement of the track rod and drag link ends with new components, the link rods being straightened during the rebuild process.

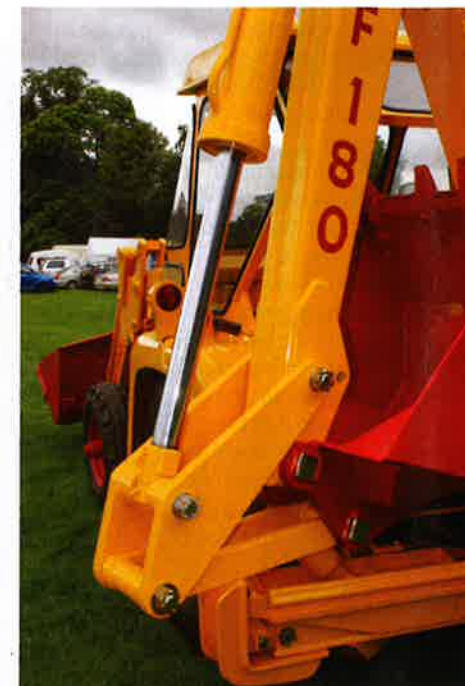
The bucket pivot and ram detail show that the square linkage pins are secured on the other side by a castle nut and split pin albeit the split pins are missing in this instance. (Photo: Jeremy Rowland)
