CLASSIC PLANT & MACHINERY

60 YEARS OF JCB LOADER-BACKHOES

JCB 3C MKIII

Julian Carder combines business with pleasure with the restoration of a classic loader-backhoe.

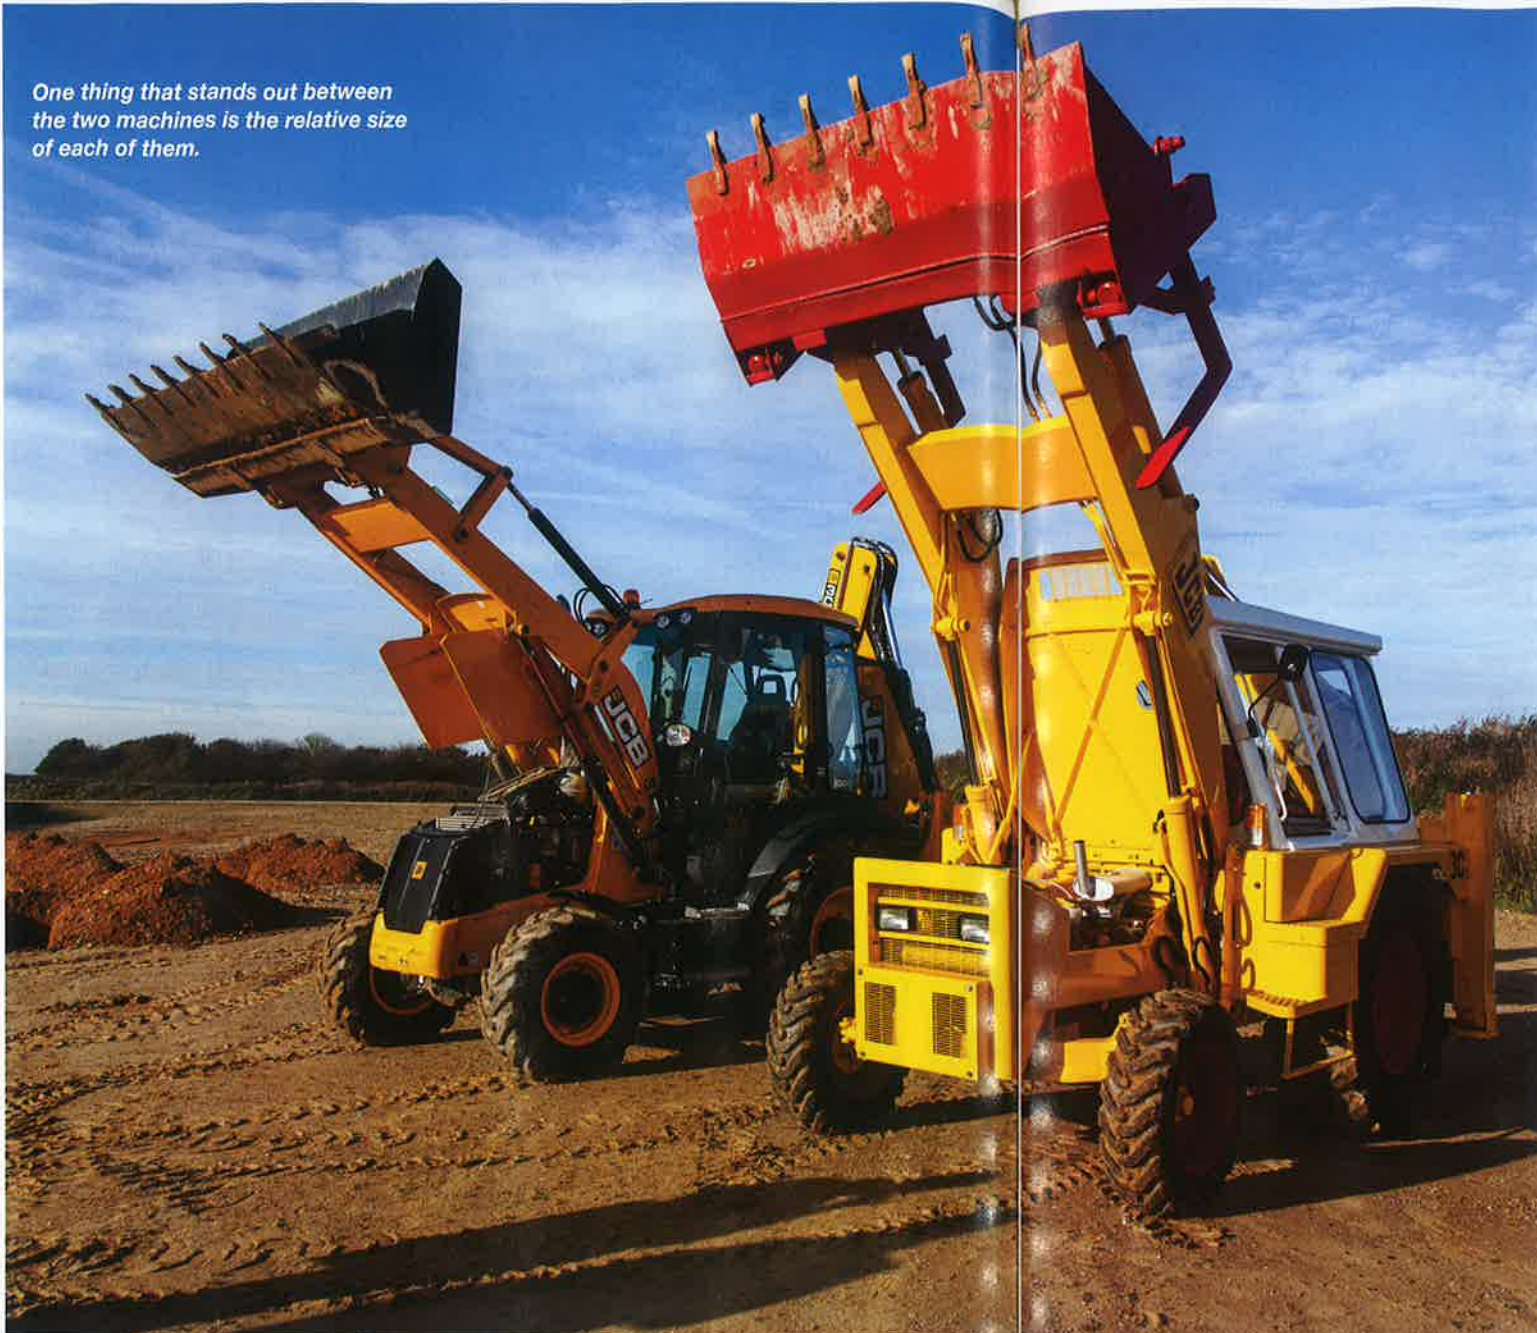
One thing that stands out between the two machines is the relative size of each of them.

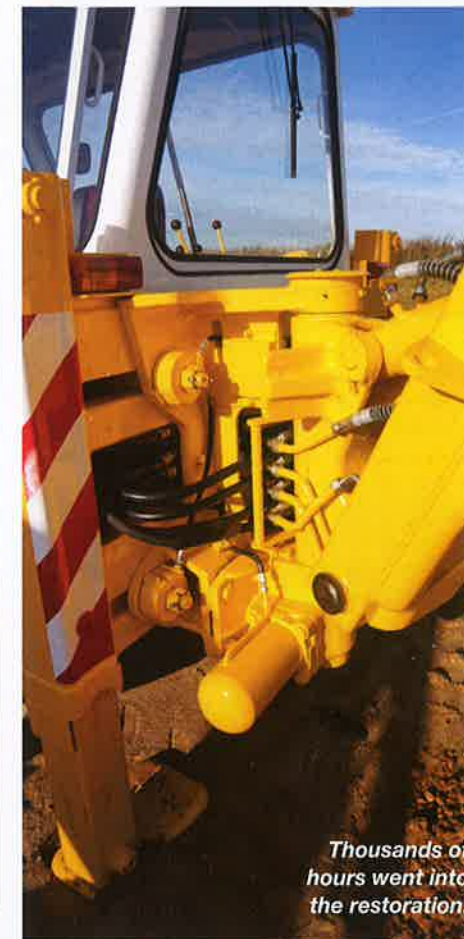
Thousands of hours went into the restoration.

Rebuilding the cab alone took £5,000 worth of painstaking work, with a local craftsman spending more than a month recreating the original structure.

The roof was littered with holes, but rather than use car filler it was opted to repair using lead for added strength. So much filler was required on the bonnet that it now takes two people to safely lift it to access the engine. The nose of the machine was also rotten, so new pressings were made and welded in.

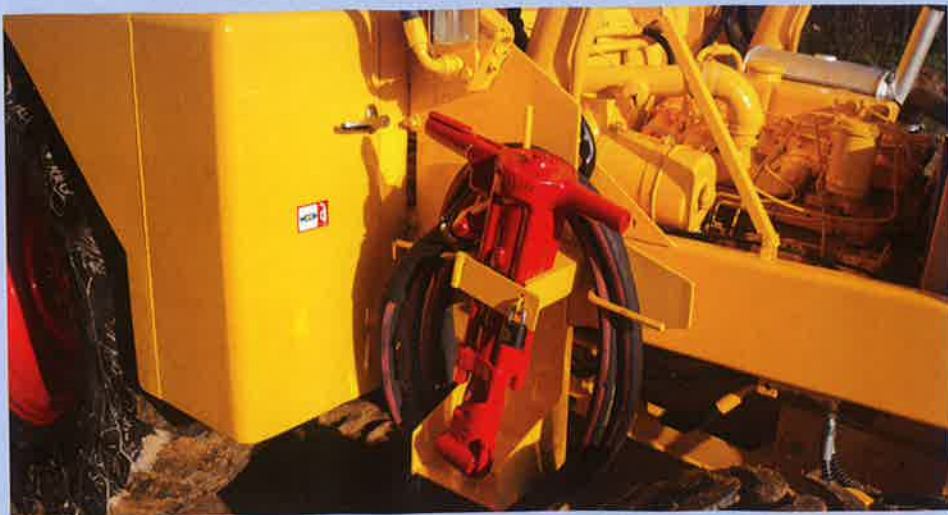
The road drilling equipment was introduced from the 3C MKII model, it is understood.

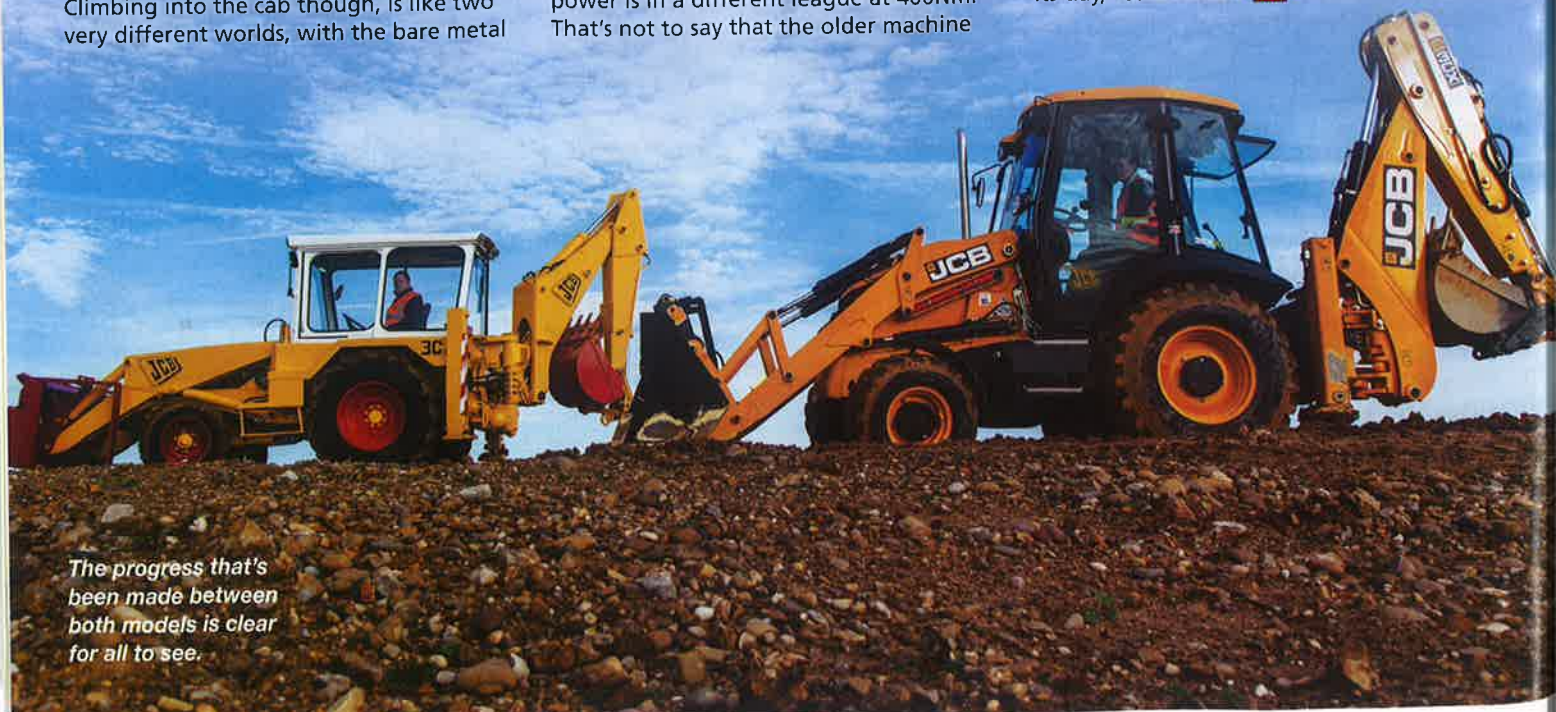
The 3C III's Leyland engine fires easily, settling into a rather lumpy idle. In its prime, this engine would have put out a heady 70hp, backed up by a strong 258Nm of torque. While today's lowest powered 3CX is not that much more powerful, at 74hp, the torque that provides the pushing power is in a different league at 400Nm. That's not to say that the older machine

A bucket from a modern excavator was used for the digging, so as not to scratch Julian's original jaw bucket. Surprisingly the bucket pins and link geometry are unchanged from the 3C III to the latest 3CX, showing that JCB got things right in 1978. "It really was a very good machine in its day," said Julian. **CPM**

The progress that's been made between both models is clear for all to see.
